Petroleum Association of Japan

Initial Lesson learned from Recent Spill
with Mutual Industry Organization

Capt Teerapol Phaparkhorn
Specialist
PTT Global Chemical Public
Company Limited

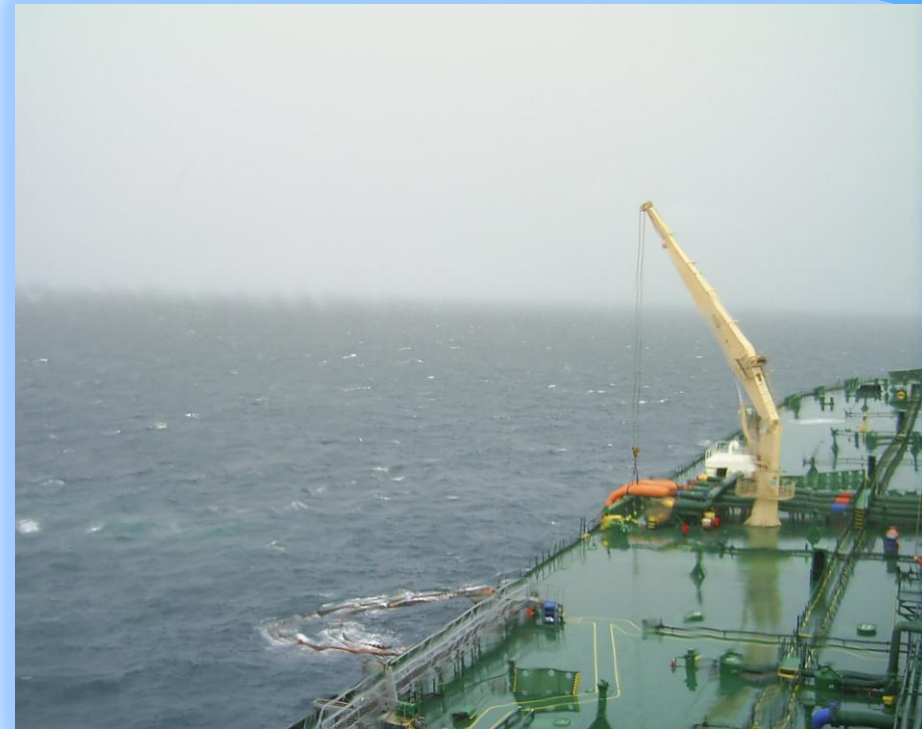
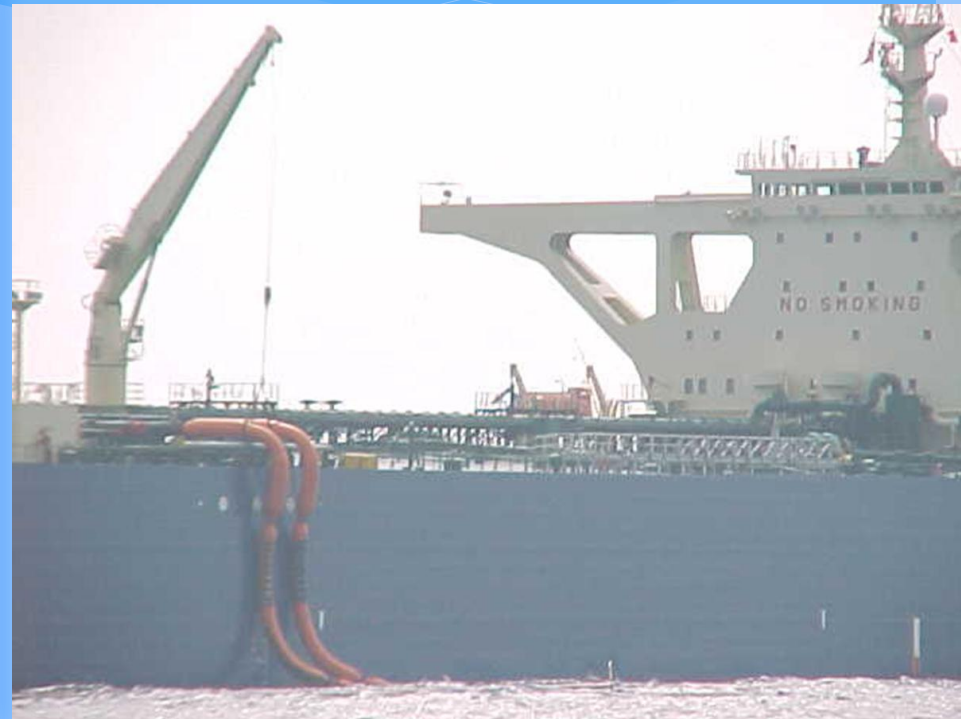
Crude Discharge via 2 of Floating Hose Strings

- * Vessel Type: Crude Oil Tanker
- * DWT: 158,795 M/T
- * LOA: 274.29 m.
- * Beam: 48.04 m.
- * Built: 2009
- * Product: Oman Crude oil
- * Time at incident : 0630 hrs
- * Incident Source: Floating hose burst
- * Spill Quantity: @50 M3

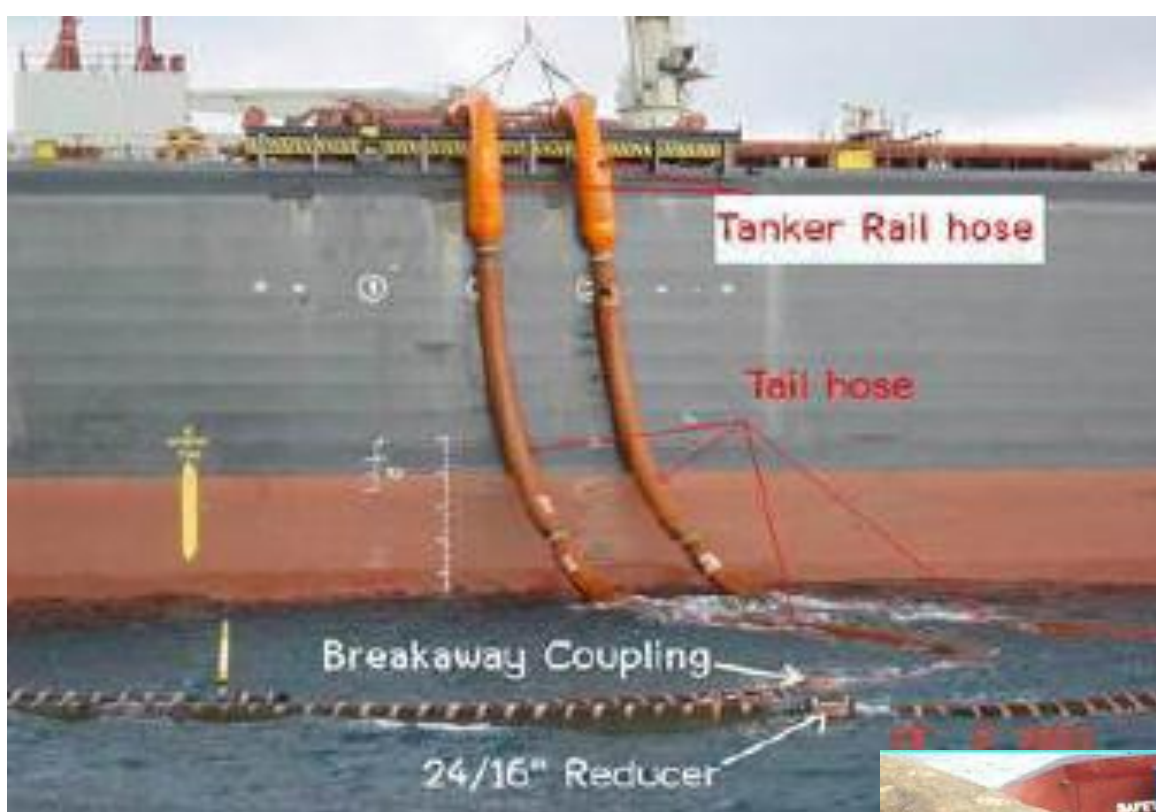
- 16" Hose single carcass failure
- Different brand from others
- 1 year and 3 months hose service life, guarantee 1 year after installed
- Purchase in Y2010
- Failed at 8.5 bars within 30 mins of discharge operation
- 10 bars maximum operation

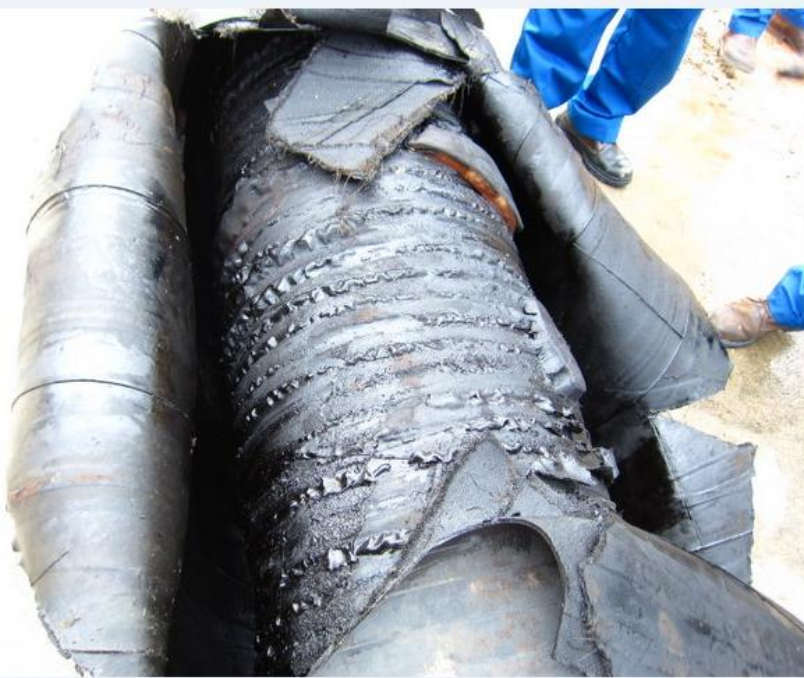
Floating Hose testing

- * Similar hose brand (burst incident – same position/service life) removed and conducted burst test and found burst at 26 bar g.
- * Other hose brand (service since Y2002) current kept as spare, conducted burst test and burst at 63 bar g.
