NATIONAL STRIKE TEAM STATION
JAPAN COAST GUARD

Response to Co-op Venture incident

Geography of location where ship ran aground

Overview of the ship and Her voyage

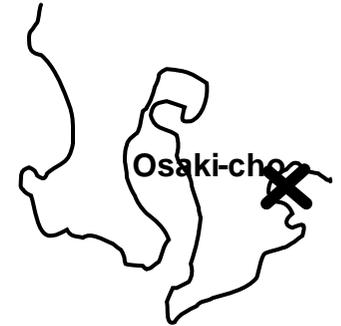
Approximately 1,500 meters southwest of the mouth of
Hishida River, Osaki-cho, Kagoshima

Photographed by Japan Coast Guard helicopter on July 26.

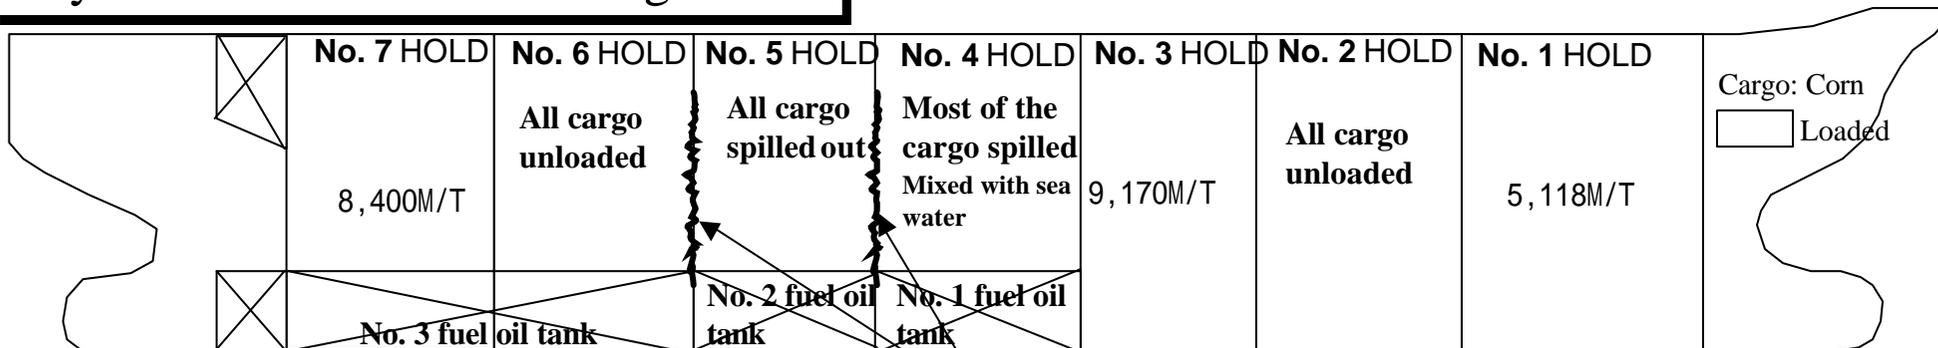
Lay-out of fuel tanks and cargo holds

Big holes on the both bulk heads

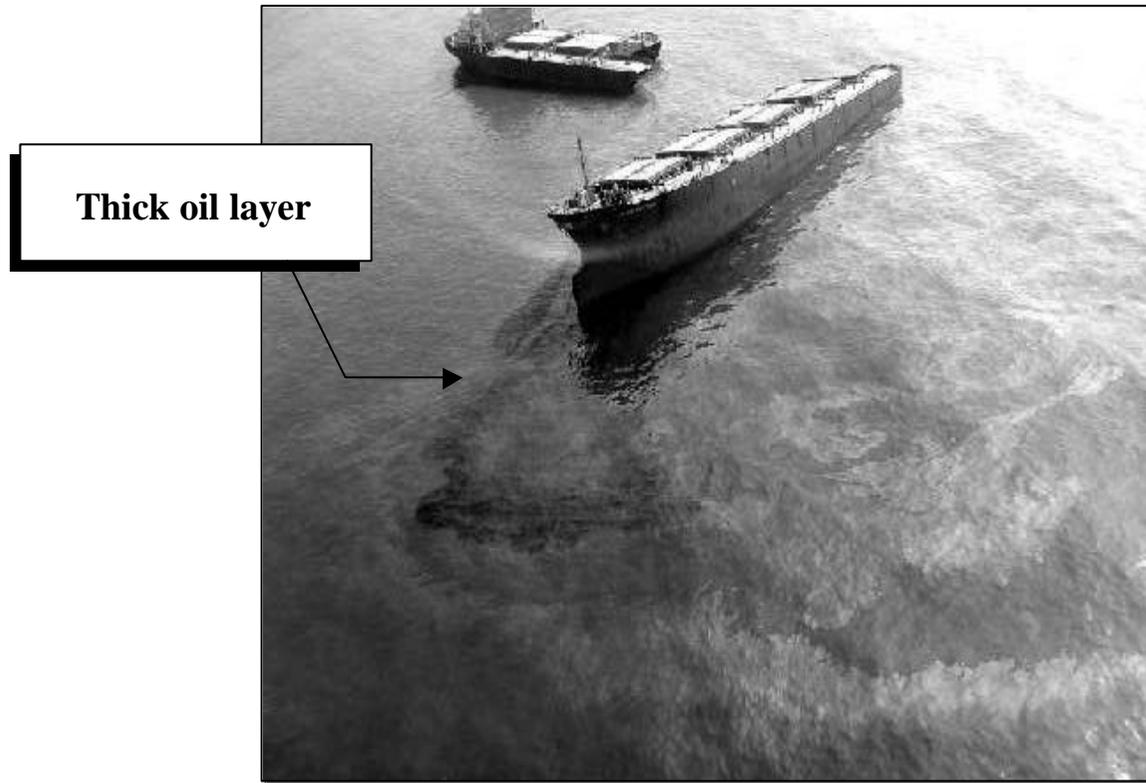
Sea surface covered with oil spilt

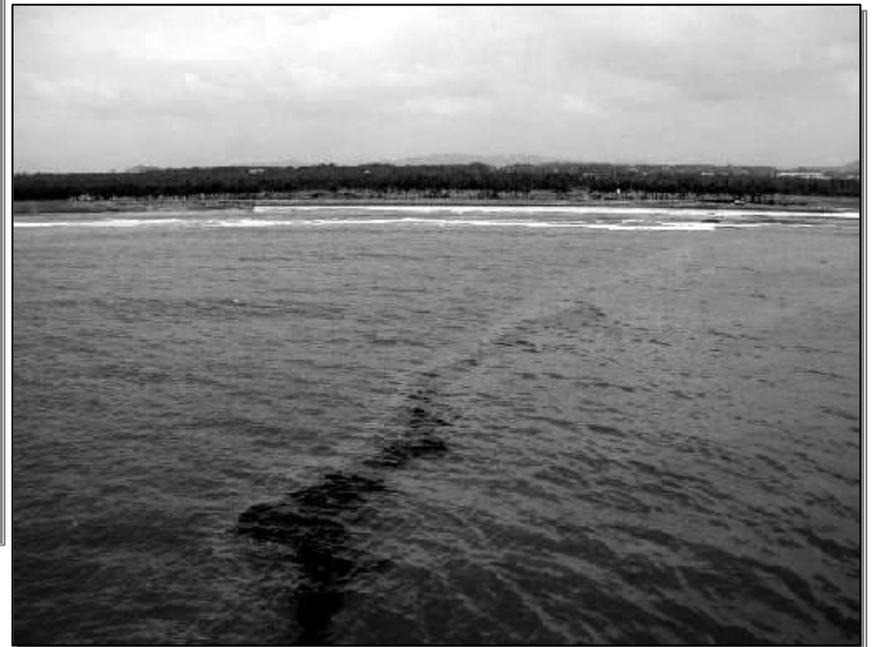
Oil slick floats towards shore

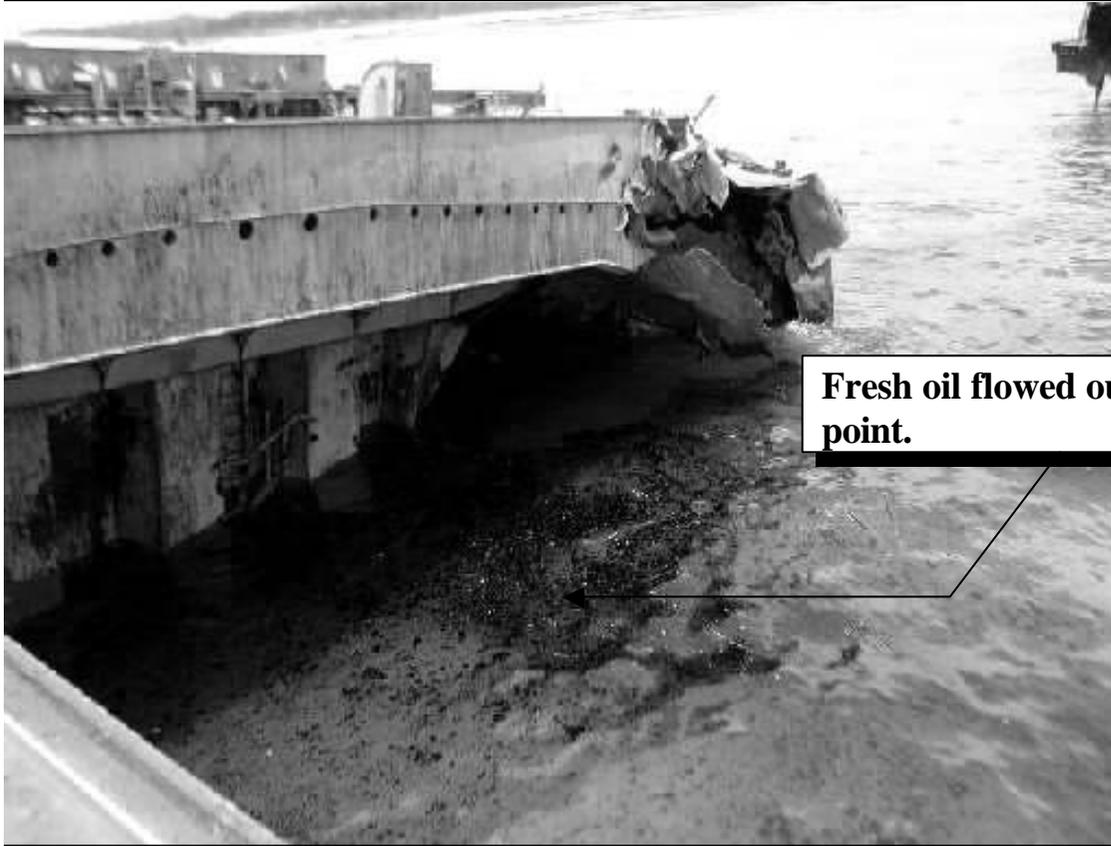
Fresh oil flowed out from this point.

Thick oil lump around the severed bow section

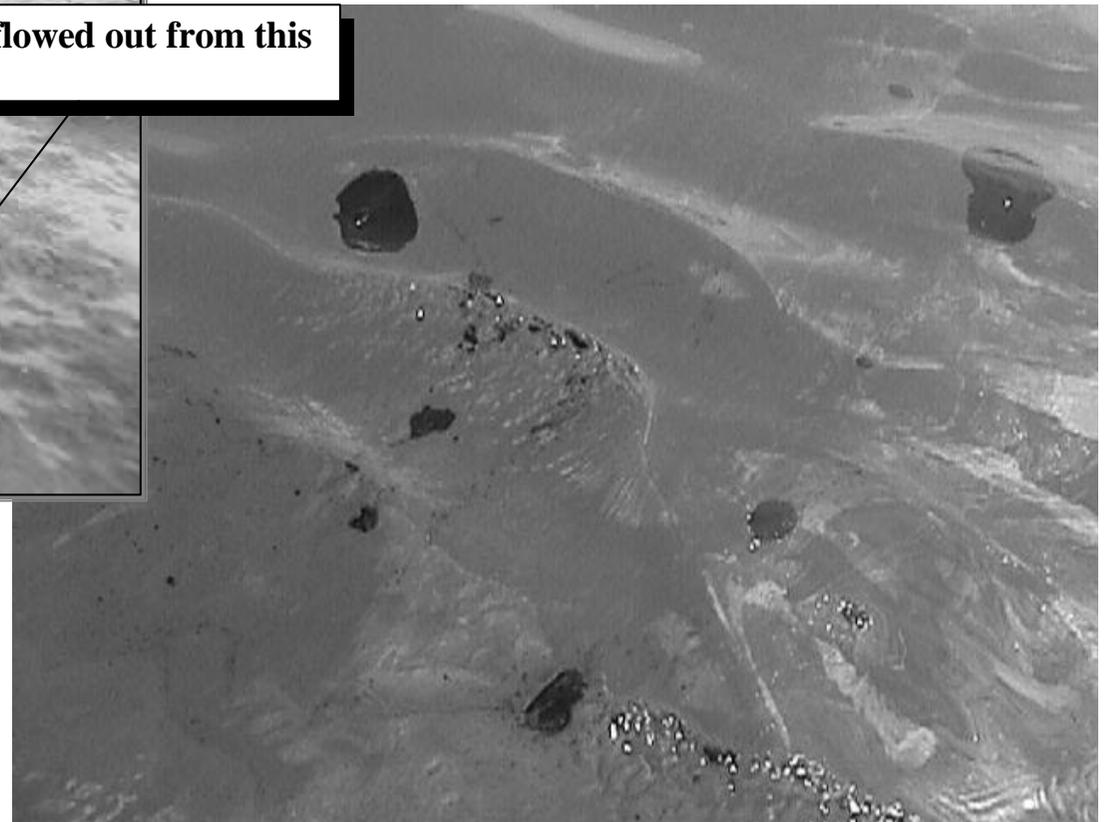
State of oil washed ashore

The spilled oil was spread by the tide and wind from the east, adhering to debris as it floated, with much of it stranded ashore onto the mouth of Tabaru River.

It is interpreted that natural dispersion of the oil was promoted by rough weather and big surf caused by the typhoon, also rising water level of Hishida and Tabaru River by rainfall on the previous days formed a natural barrier, led majority of the oil to drift ashore on relatively narrow area than originally expected.

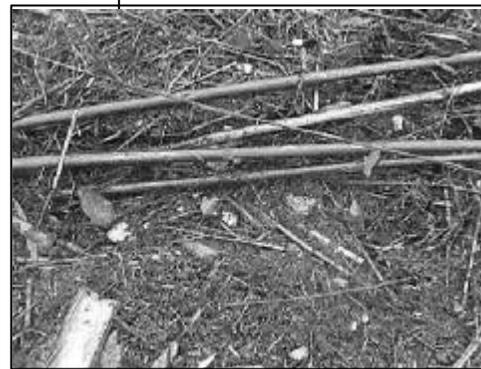
Debris covered with oil

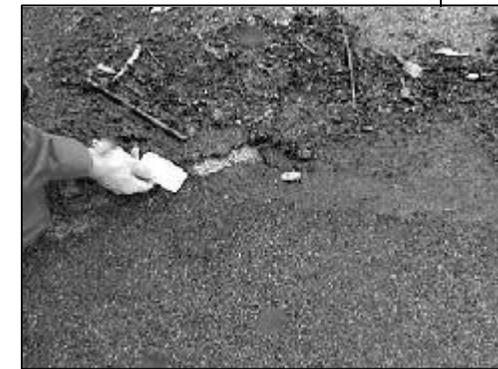
Stranded onto sandy shore

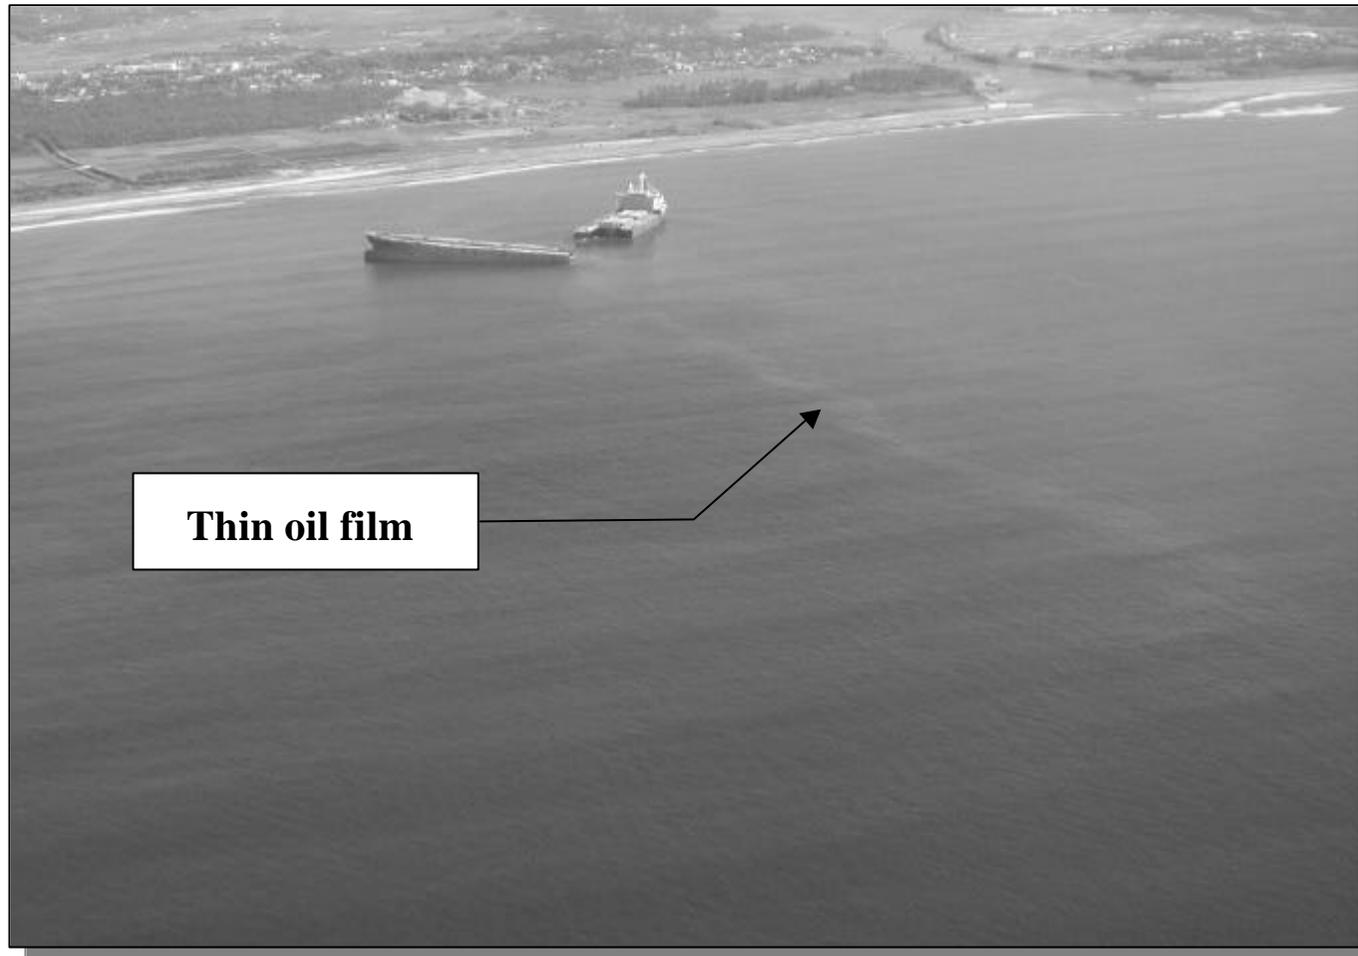
Situation of the spilt oil after oil spread prevention

No thick oil layer remaining on the sea surface,
but a thin oil film, formed by oil oozing from the oil adhered to the “oil snare”, floats on
the water, and the outer reaches thereof are **dispersed** by wind and waves.

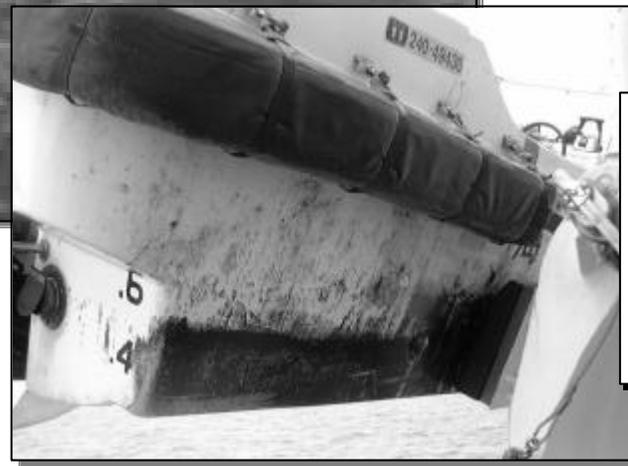
The rescue patrol boat is blackened by the oil spilt.

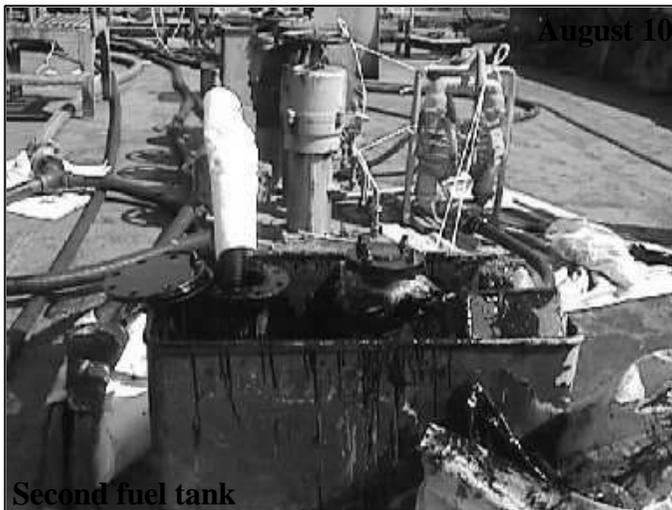
Second fuel tank

Withdrwing oil from air vent pipe

Amount of oil
recovered
659 kl

No. 1: 235 kl
No. 2: 38 kl
Rear tank: 386 kl
