KOEM Korea Marine Environment Management Corporation

1. Incident Outline

1 - 1 Cause of Incident

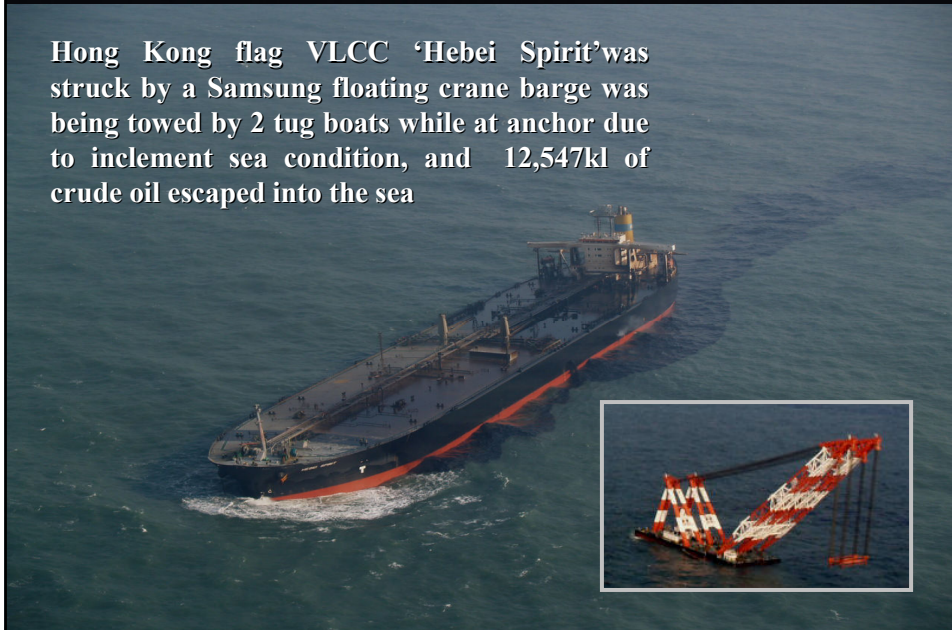
1 - 2 Punctured

- ▶ No.1 Port : 30 x 3cm
- ▶ No.3 Port : 160 x 10cm
- ▶ No.5 Port : 200 x 160cm

Single hull tanker built in 1993

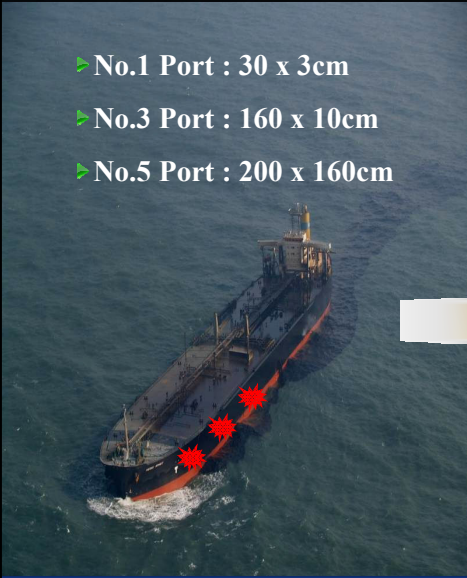
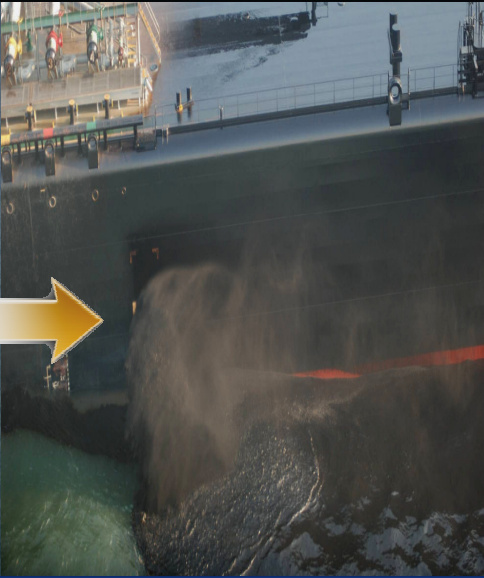
1 - 3 Patching

- ▶ 2 punctured holes were soon repaired soon but the remaining hole took time to patch

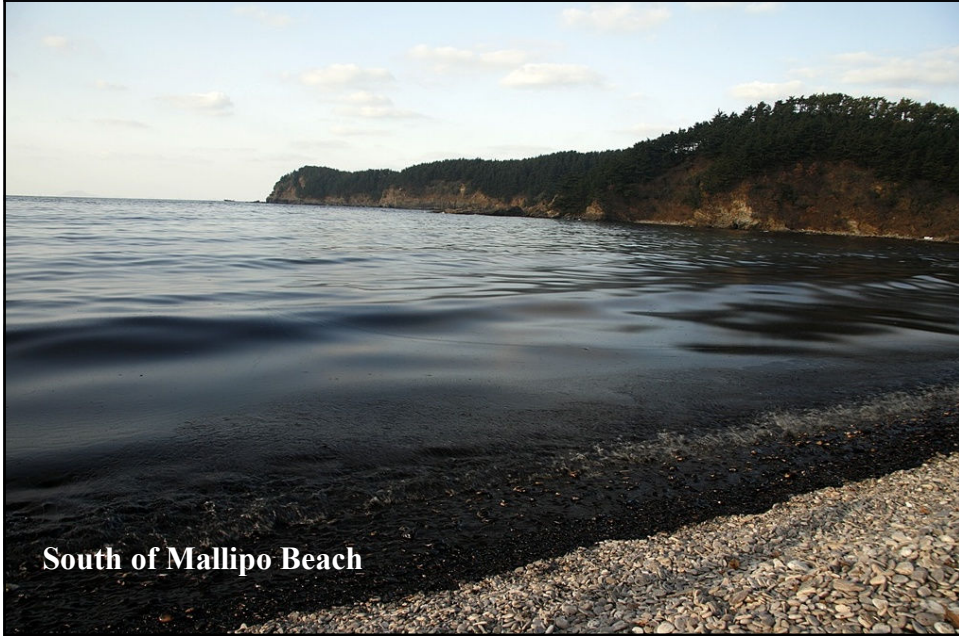
1 - 6 Pollution Status

South of Mallipo Beach

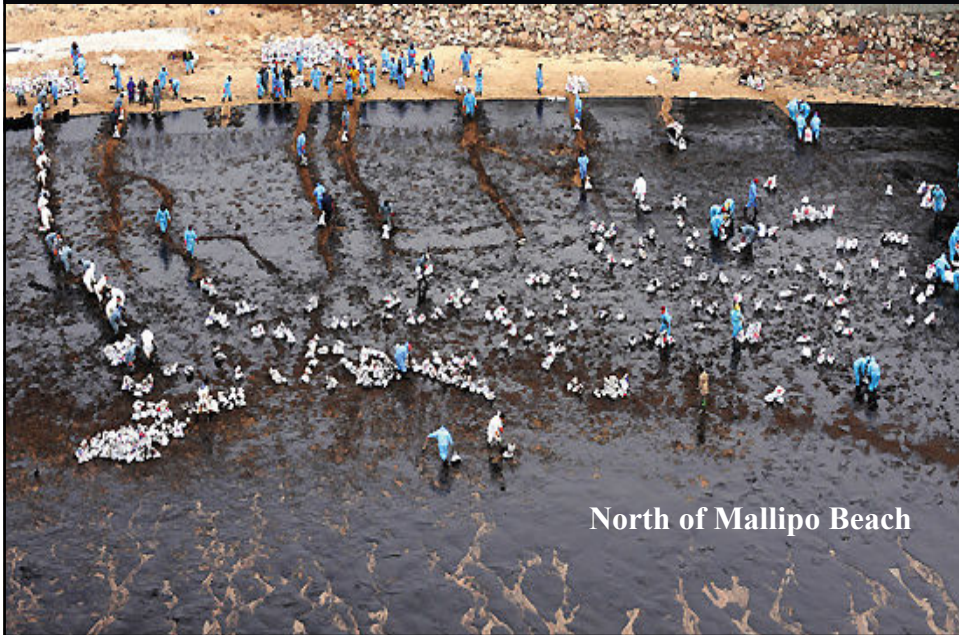
1 - 7 Pollution Status

North of Mallipo Beach

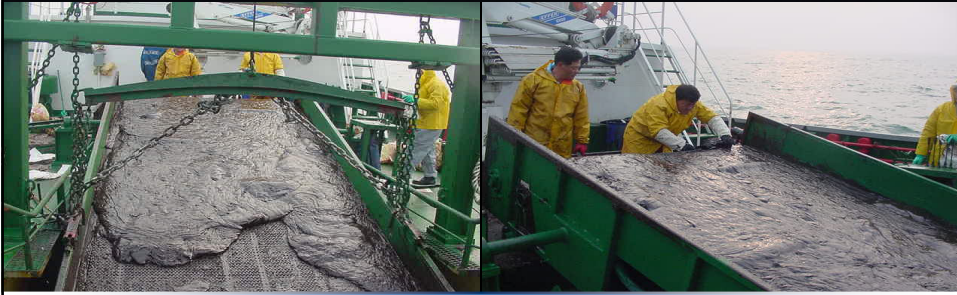
Filterbelt Skimmers

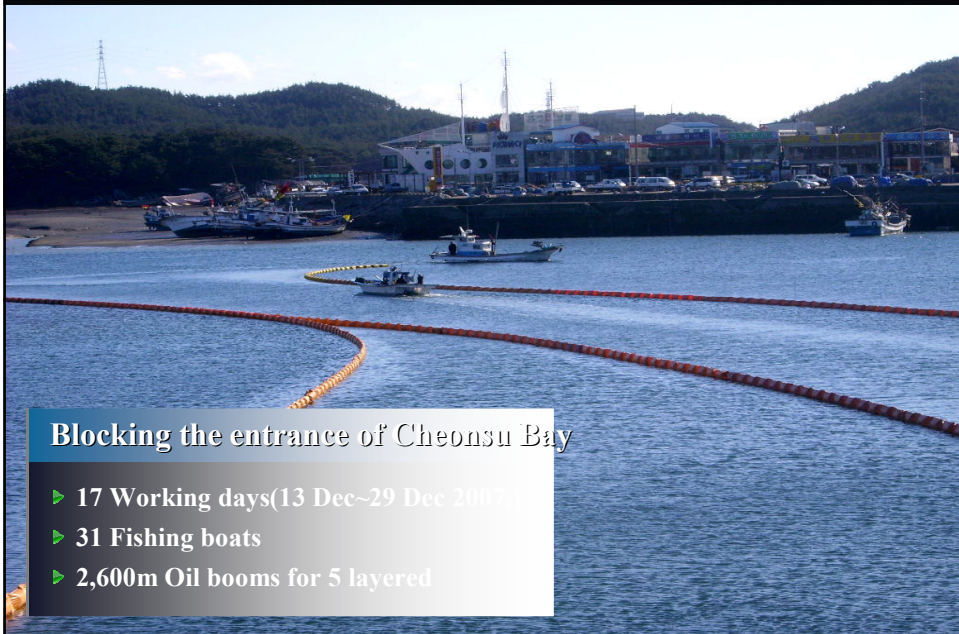
3 - 3 Protection of Cheonsu Bay

Blocking the entrance of Cheonsu Bay

- ▶ 17 Working days(13 Dec~29 Dec 2007)
- ▶ 31 Fishing boats
- ▶ 2,600m Oil booms for 5 layered

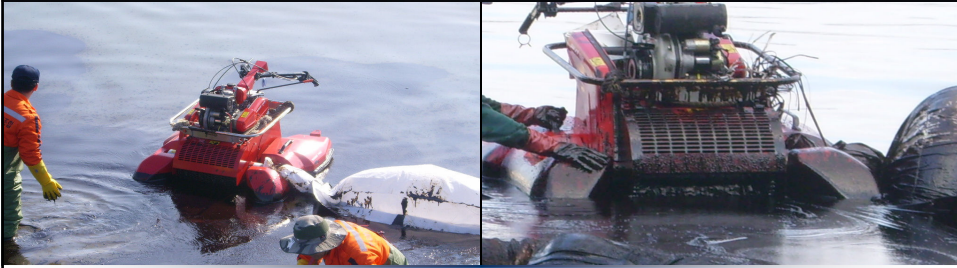
Unisep (Drum type)

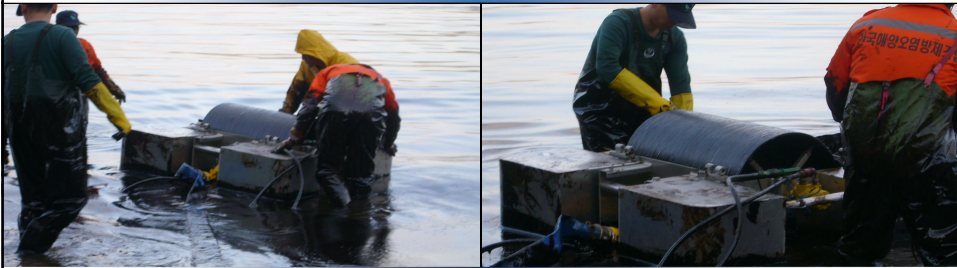
Uniskim (Drum type)

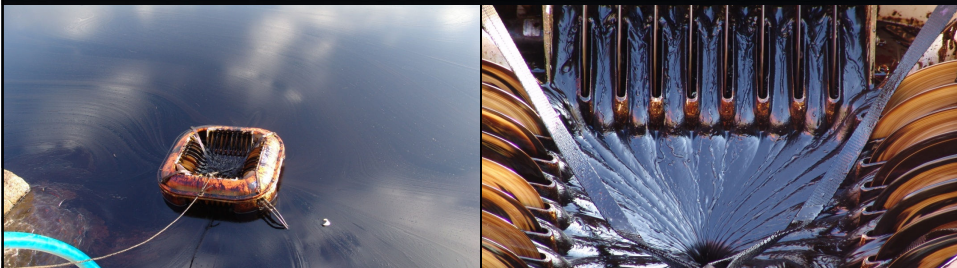
Komara 20K (Disc type)

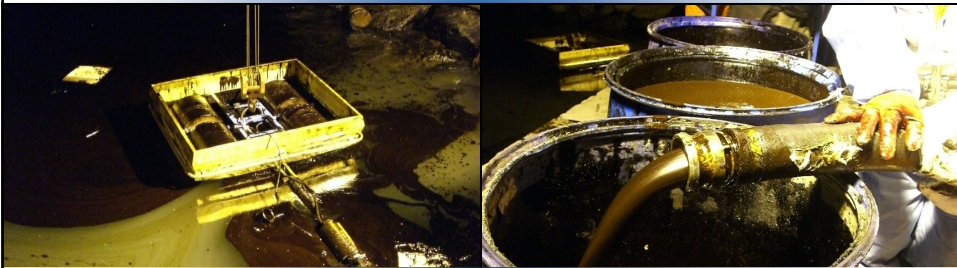
Magnum 100 (Drym type)

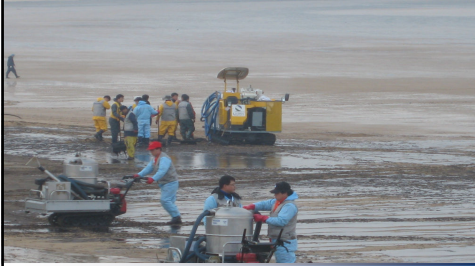
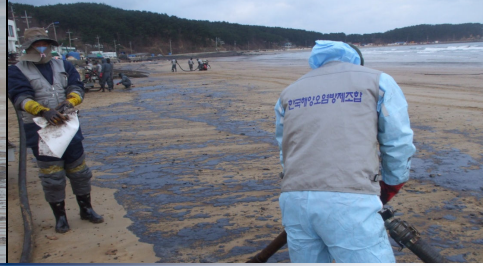
Mini-Vac (Vacuum device)

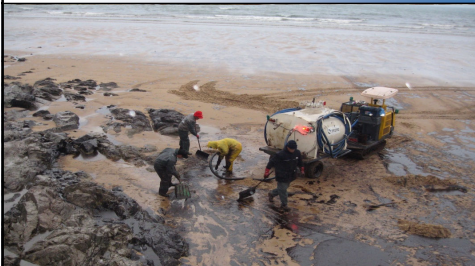
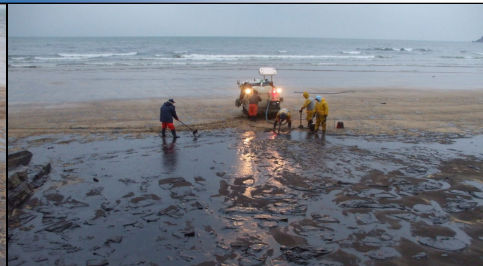
SMBC50 (Vacuum tank)

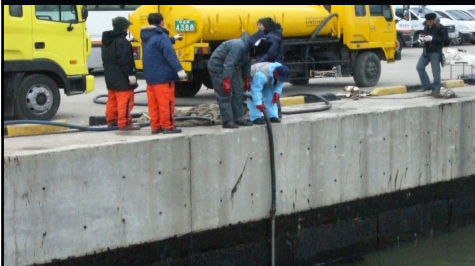
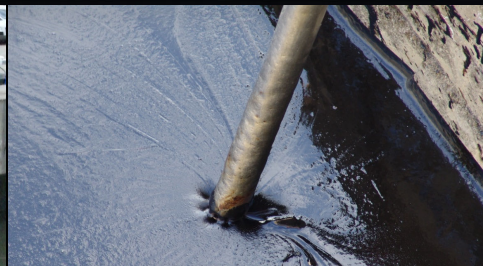
Skimming via vacuum vehicle

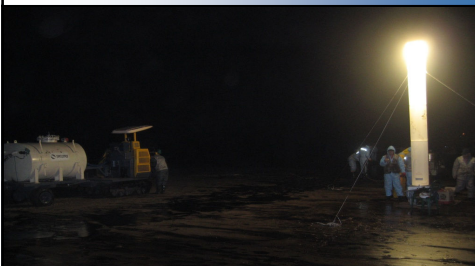
Light for night working

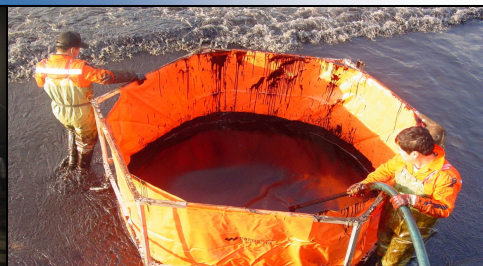
Temporary storage(5ton)

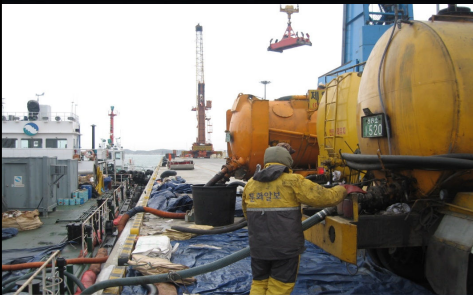
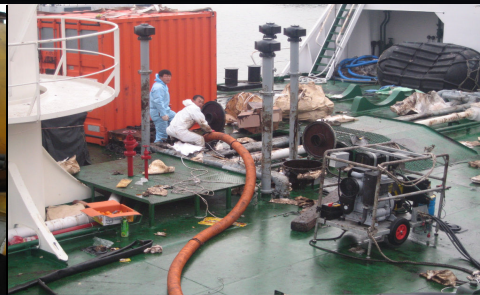
7 - 1 Transferring Oil Collected at Sea

Transfer collected oil from oil barge to vacuum vehicles
