Montara Wellhead Platform Incident

Toby Stone - General Manager - Marine Environment Division

Australian Maritime Safety Authority

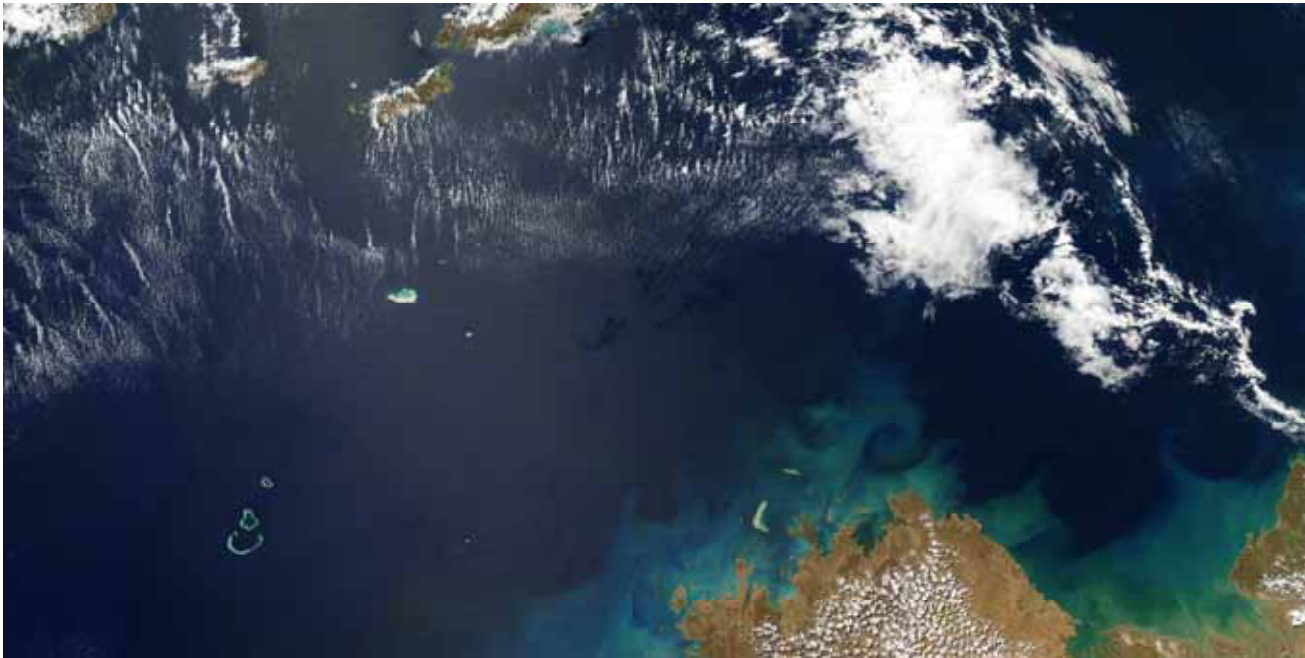
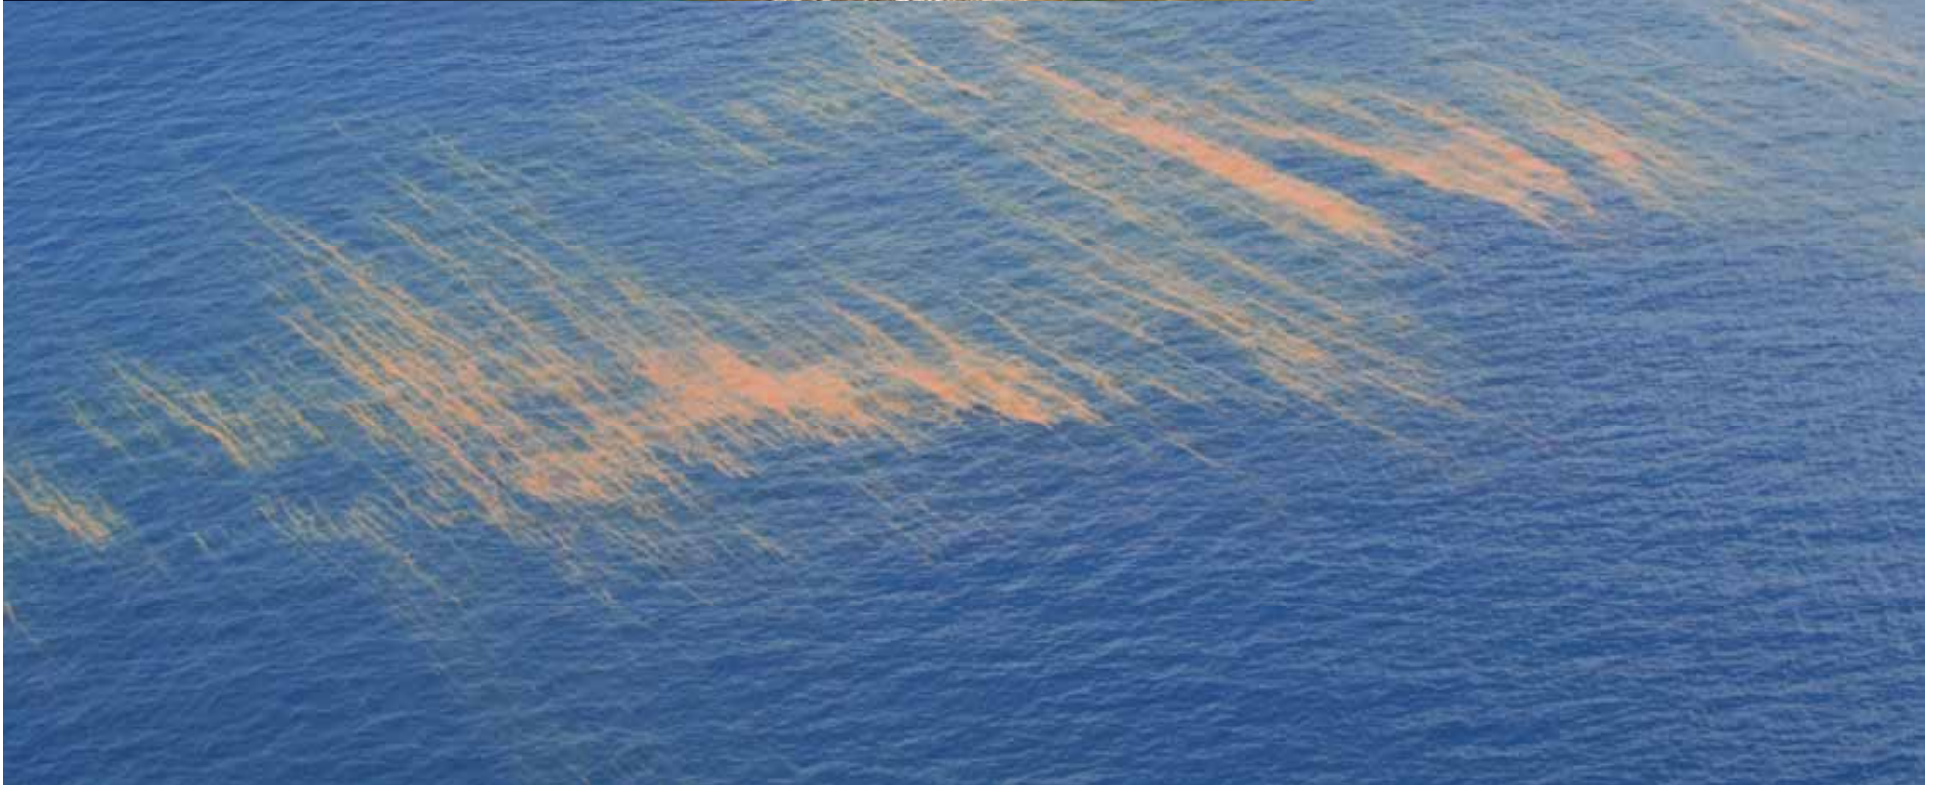
Montara Well Observed Oil Extent

This image does not represent the extent of any oil slick observed at any time during the oil spill. It is a graphic representation of the area within which isolated patches of oil and/or sheen were observed by surveillance aircraft on 130 separate flights between 21 August 2009 and 28 November 2009.

Natural phenomena such as algal blooms and coral spawn with an appearance very similar to oil were regularly reported throughout the area during the surveillance operations, and may have had some impact on the accuracy of this data.

Oil observation frequency describes the number of times oil and/or sheen was observed on the 130 separate surveillance flights undertaken between 21 August 2009 and 28 November 2009.

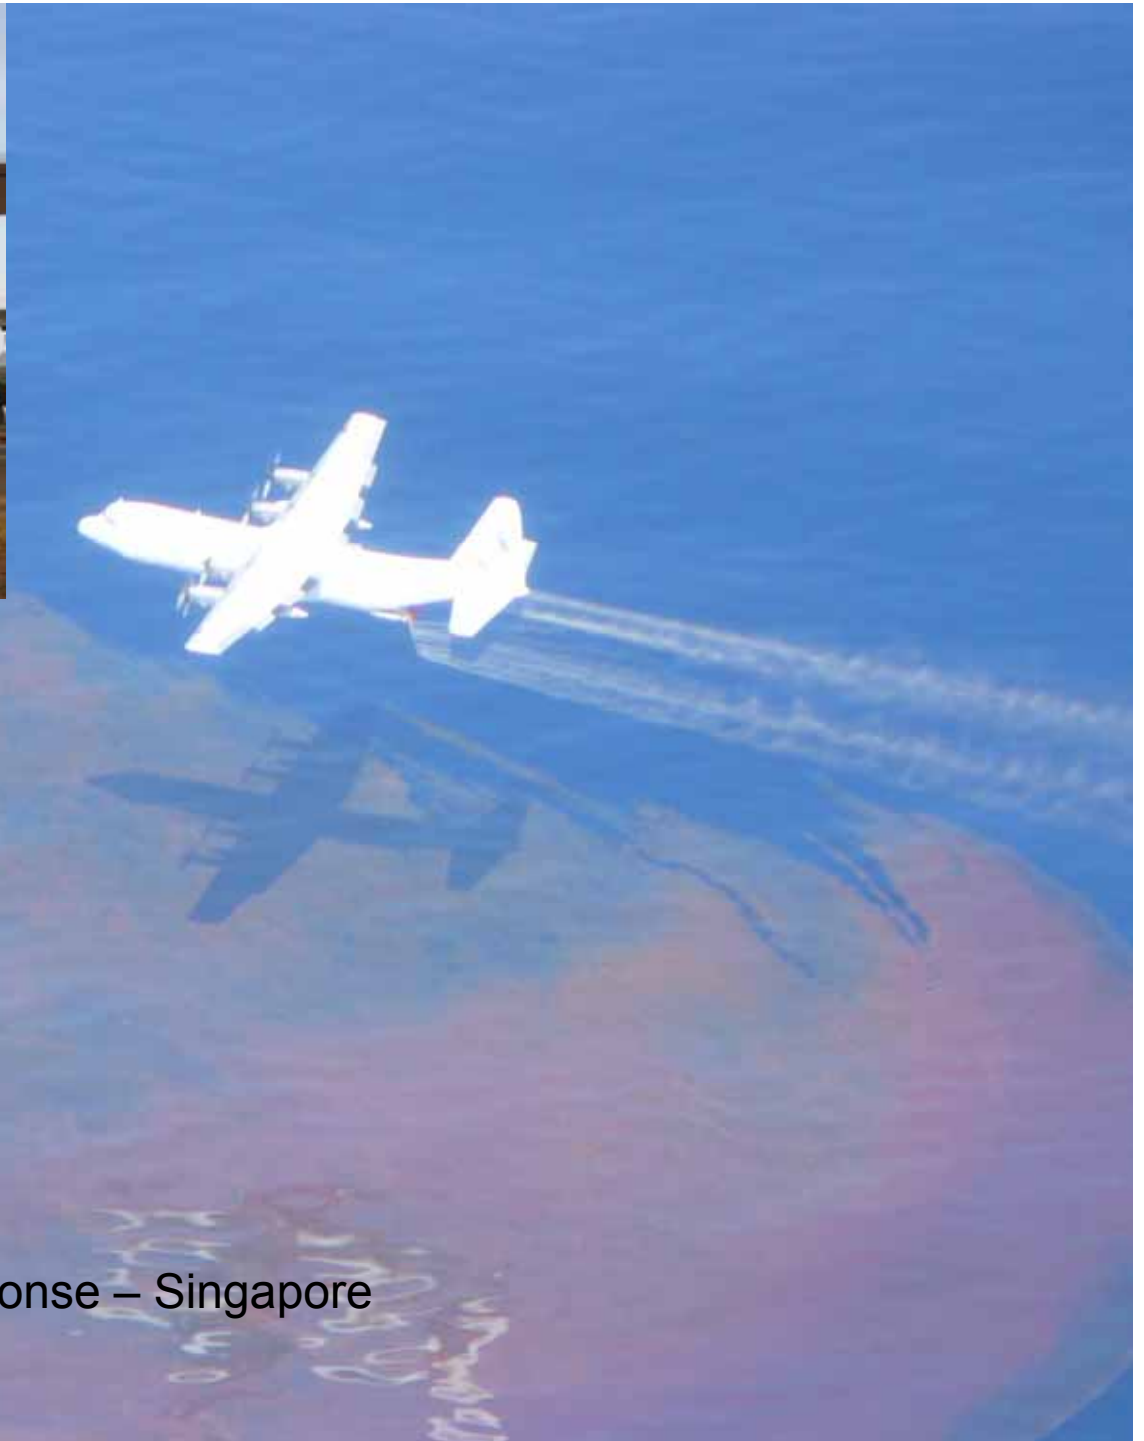
Hercules C130 from Oil Spill Response – Singapore
Sprayed 12,000 litres over 2 days

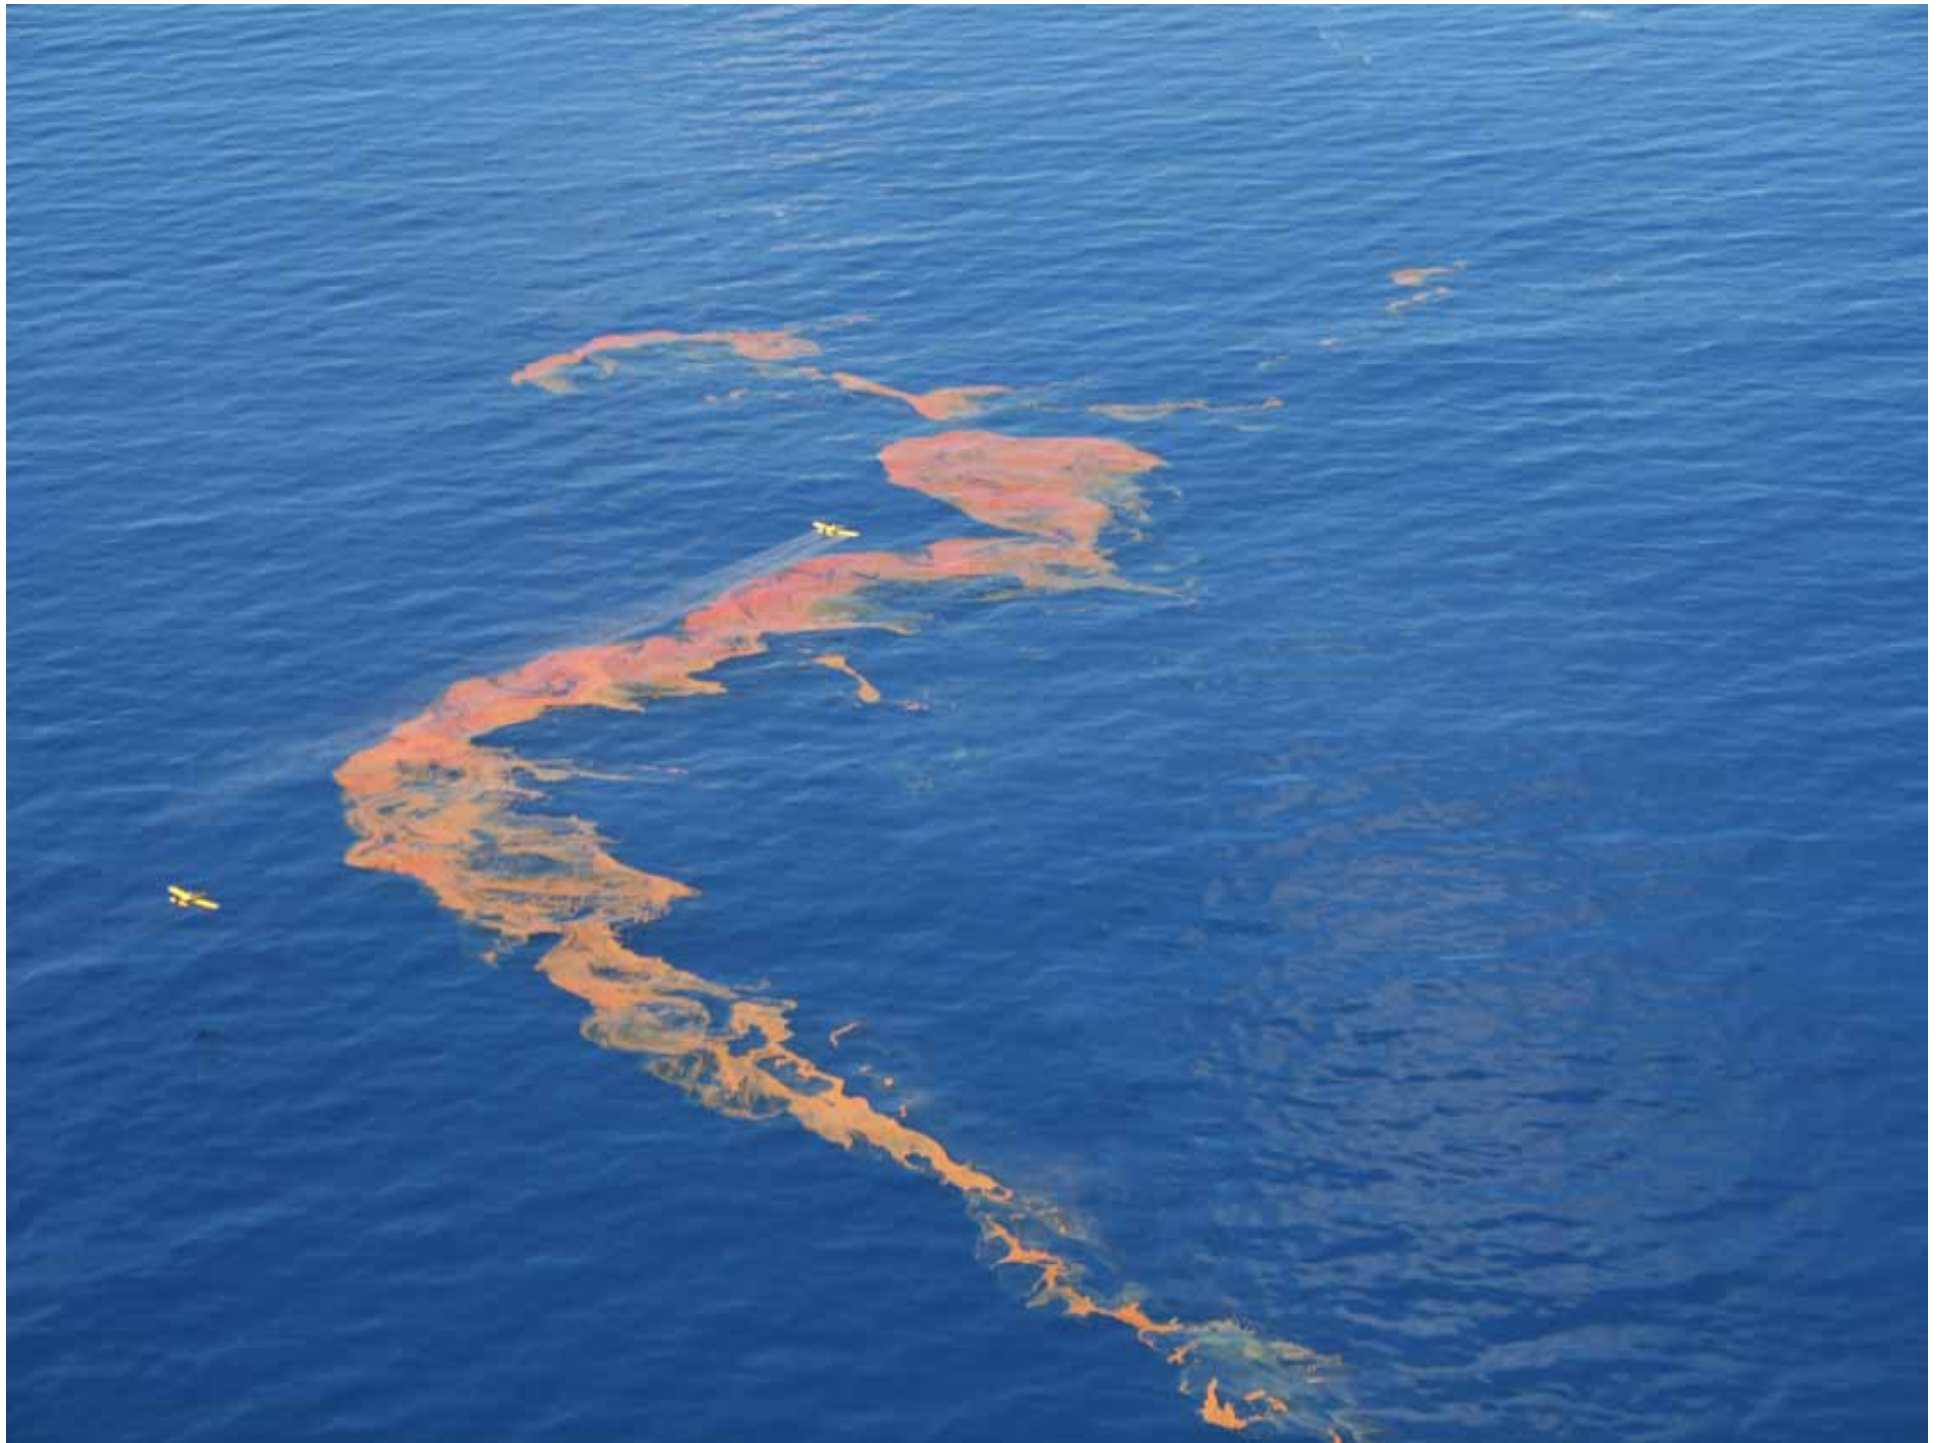
Montara well head platform – Dispersant summary

Dispersants used to date are Slickgone NS, Slickgone LTSW, Ardrox 6120, Tergo R40, Corexit 9500 and Corexit 9527.

Only dispersants that pass a specified *minimum level of effectiveness* and a specified *maximum level of acceptable toxicity* to two temperate and two tropical test species are approved for use in Australian waters. For more information go to:

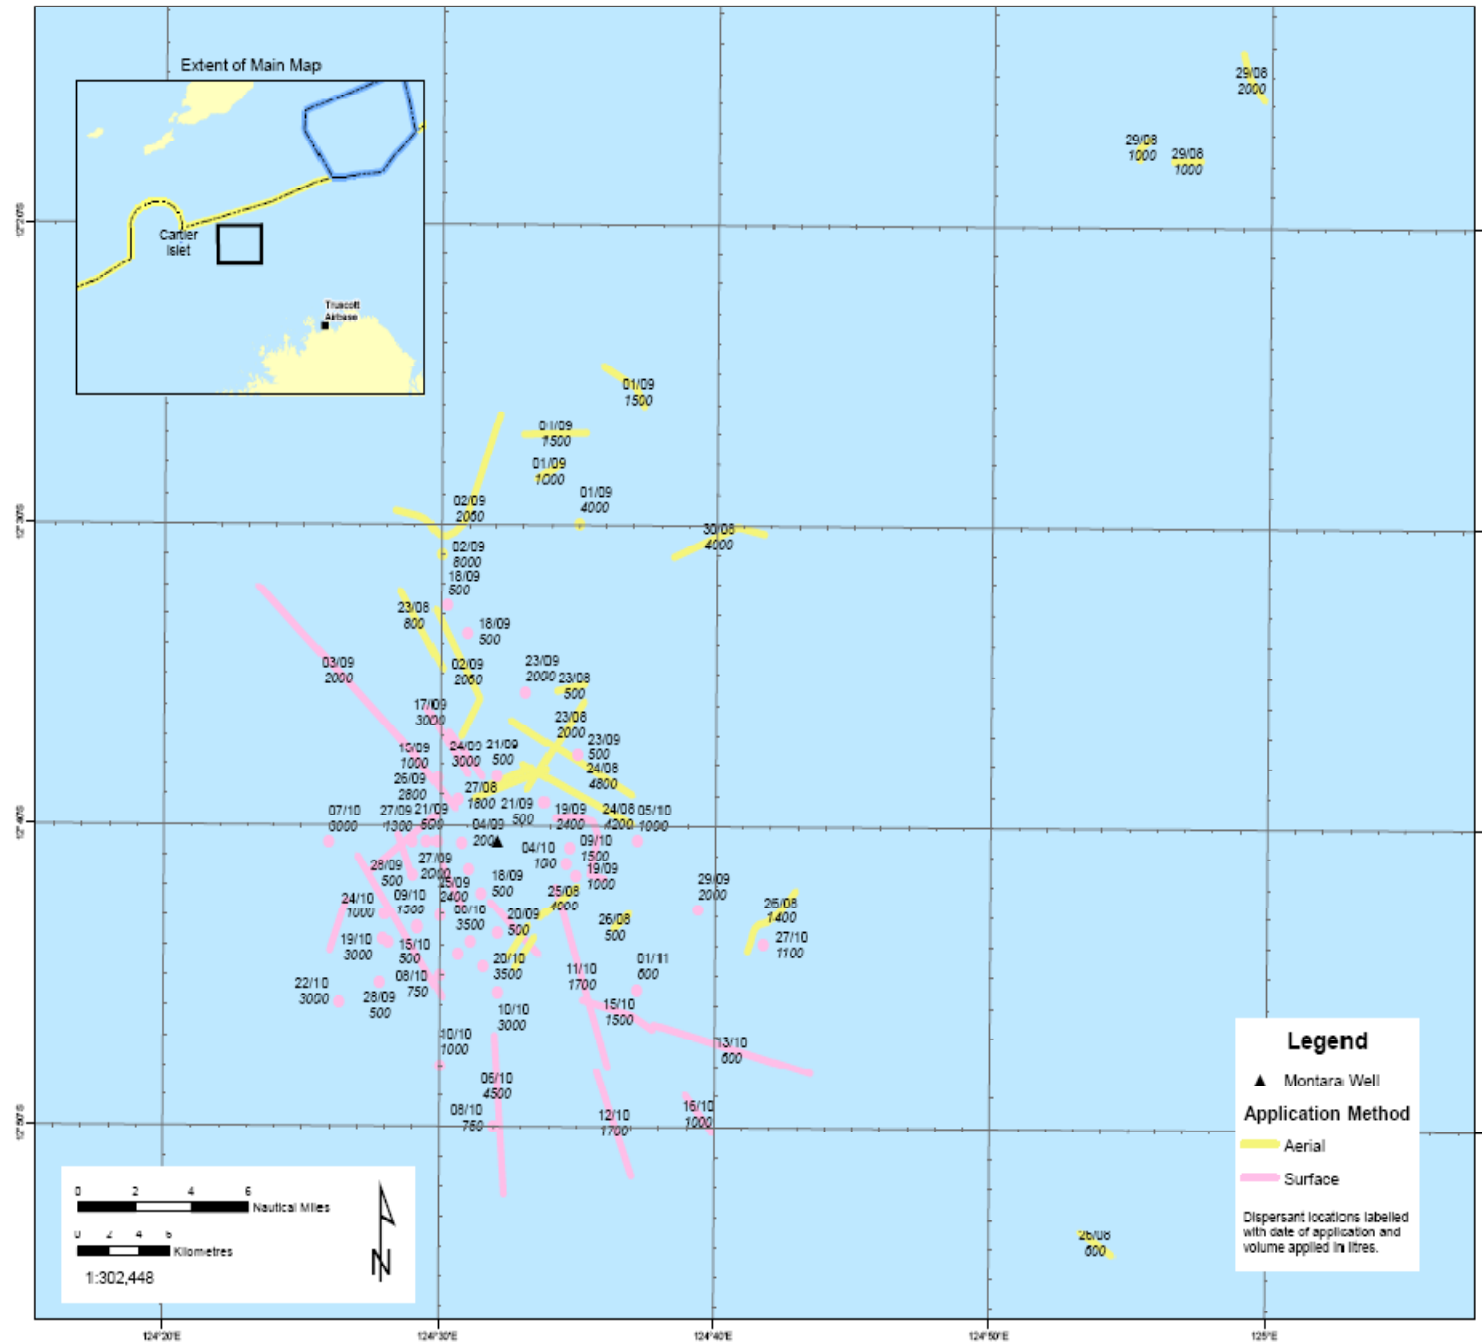
Montara Well Dispersant Application

Dispersant locations and volumes compiled from the daily situation reports issued by the Manager, Environment Protection, AMSA and also the daily reports provided by the Masters of the ships performing oil recovery and dispersal operations.

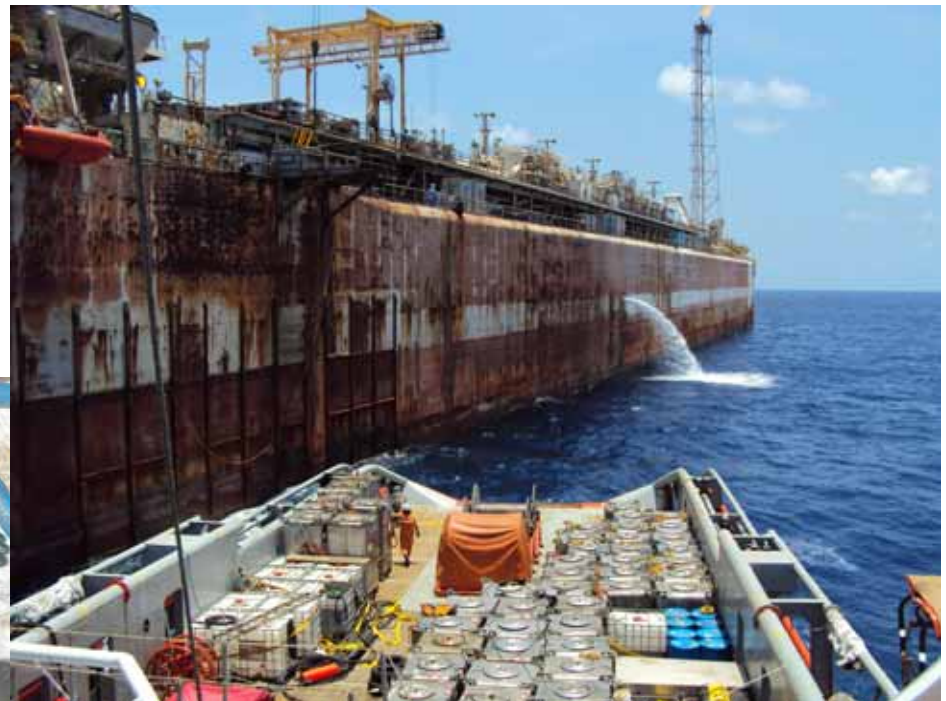
Well Repair Plan

How the Montara Platform leak will be stopped
