ITOPF's Spill Response During the Pandemic **COVID-19: A POSITIVE EXPERIENCE?**

Richard H. Johnson, Technical Director

Petroleum Association of Japan Symposium

22 Feb 2022

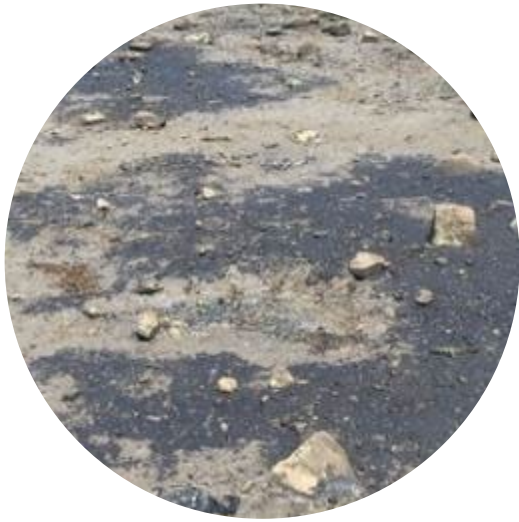
VLSFO

- Viscosity: 34 cSt at 50°C when fresh
- Low viscosity maintained for months
- Less sticky than conventional fuels
- Permeated deep into sandy sediment
- Infiltrated mangrove mud via animal burrows and root network

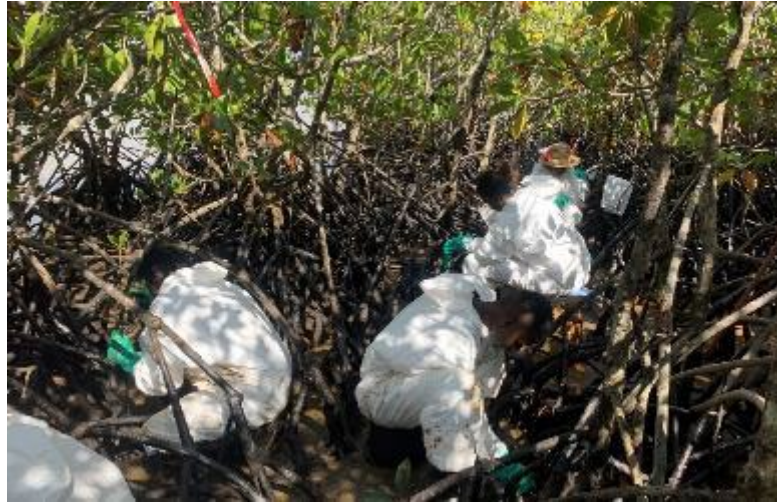
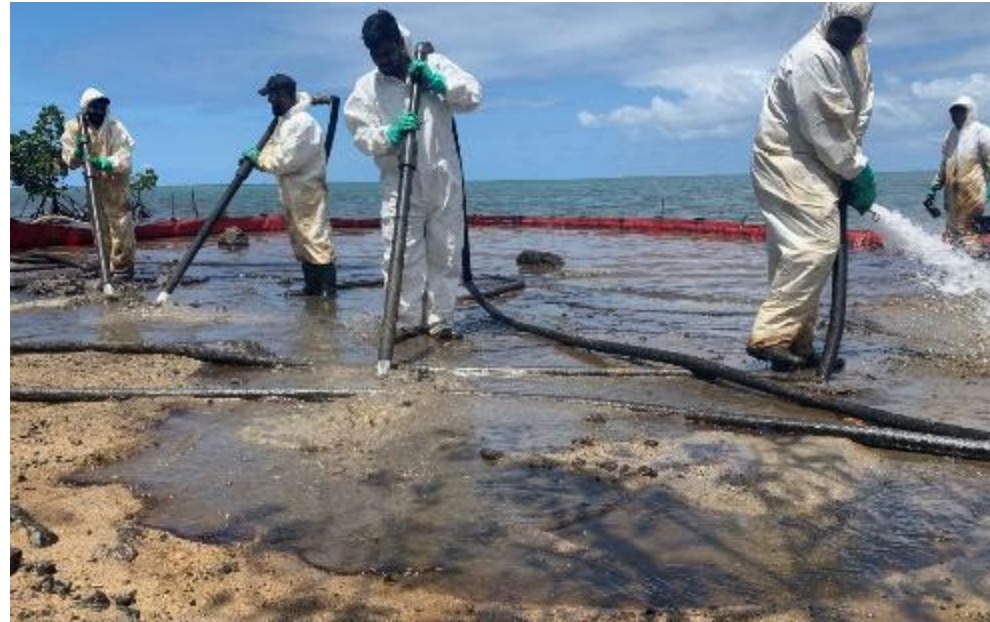
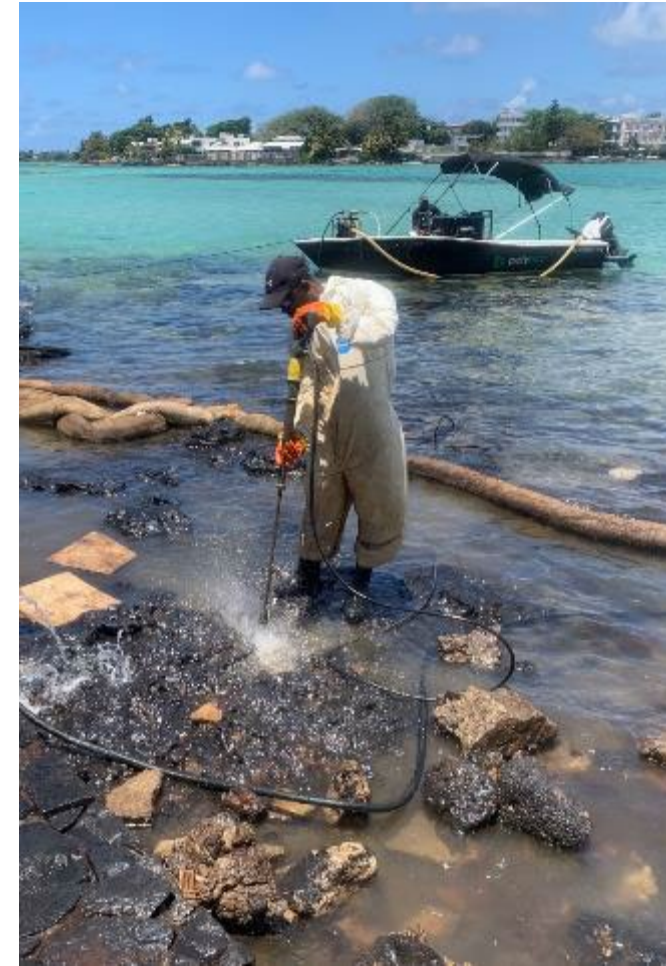
SHORELINE CLEANUP TECHNIQUES

- Manual collection
- High volume low pressure flushing
- Hot water high pressure washing

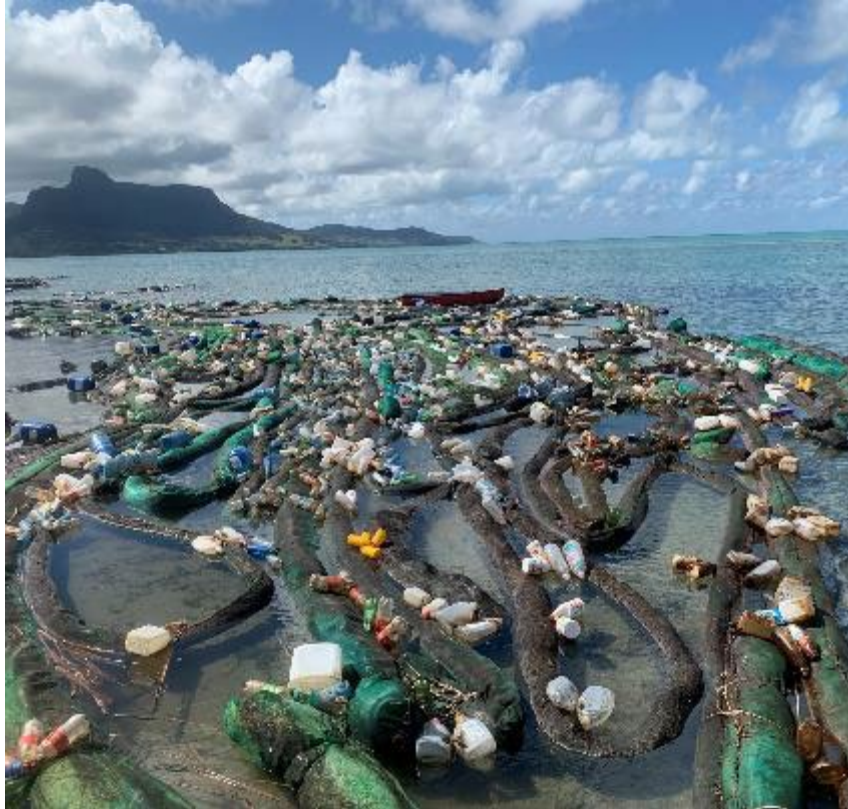
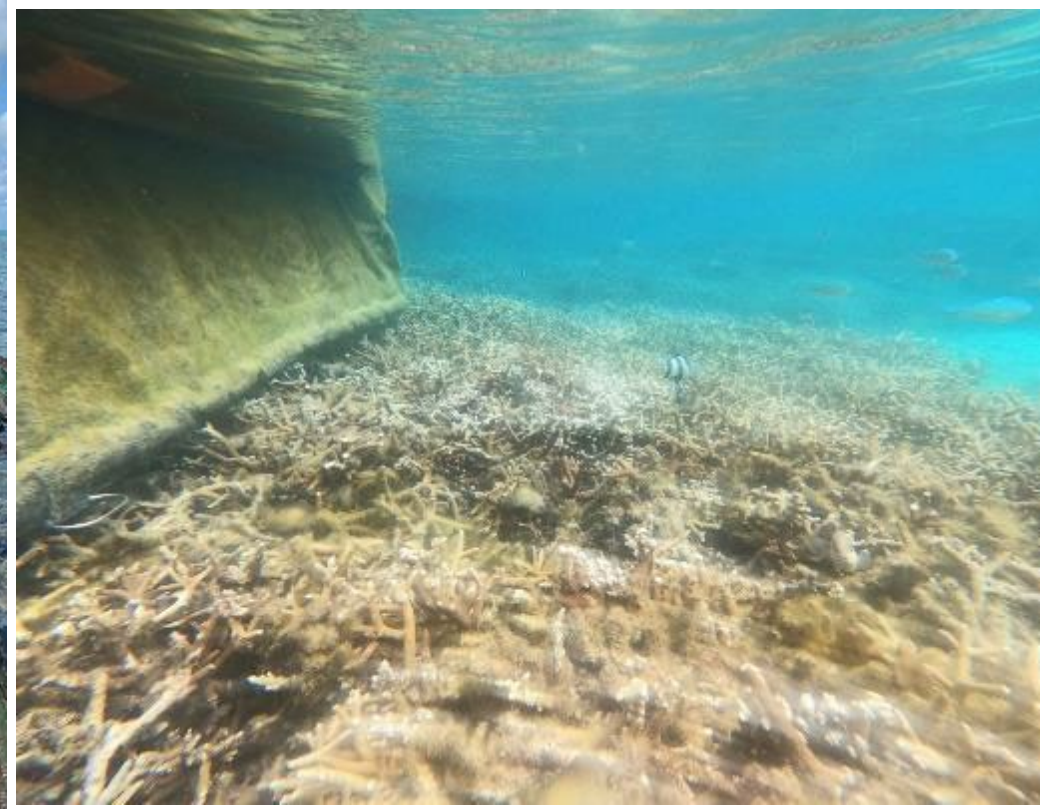
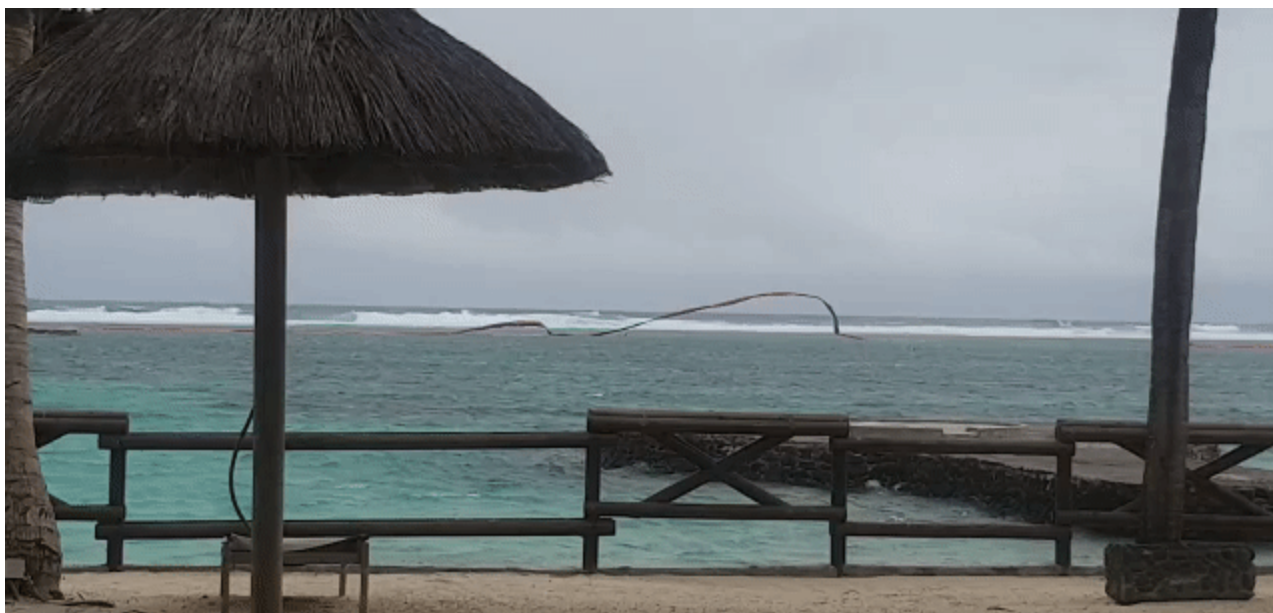
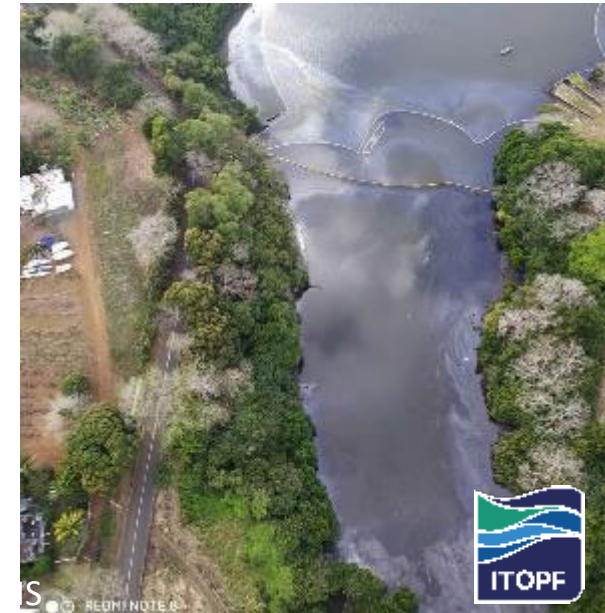
KEY ISSUES

- Remobilisation
- Improvised boom
- Boom failure
- Coral damage
- Waste collection
- COVID

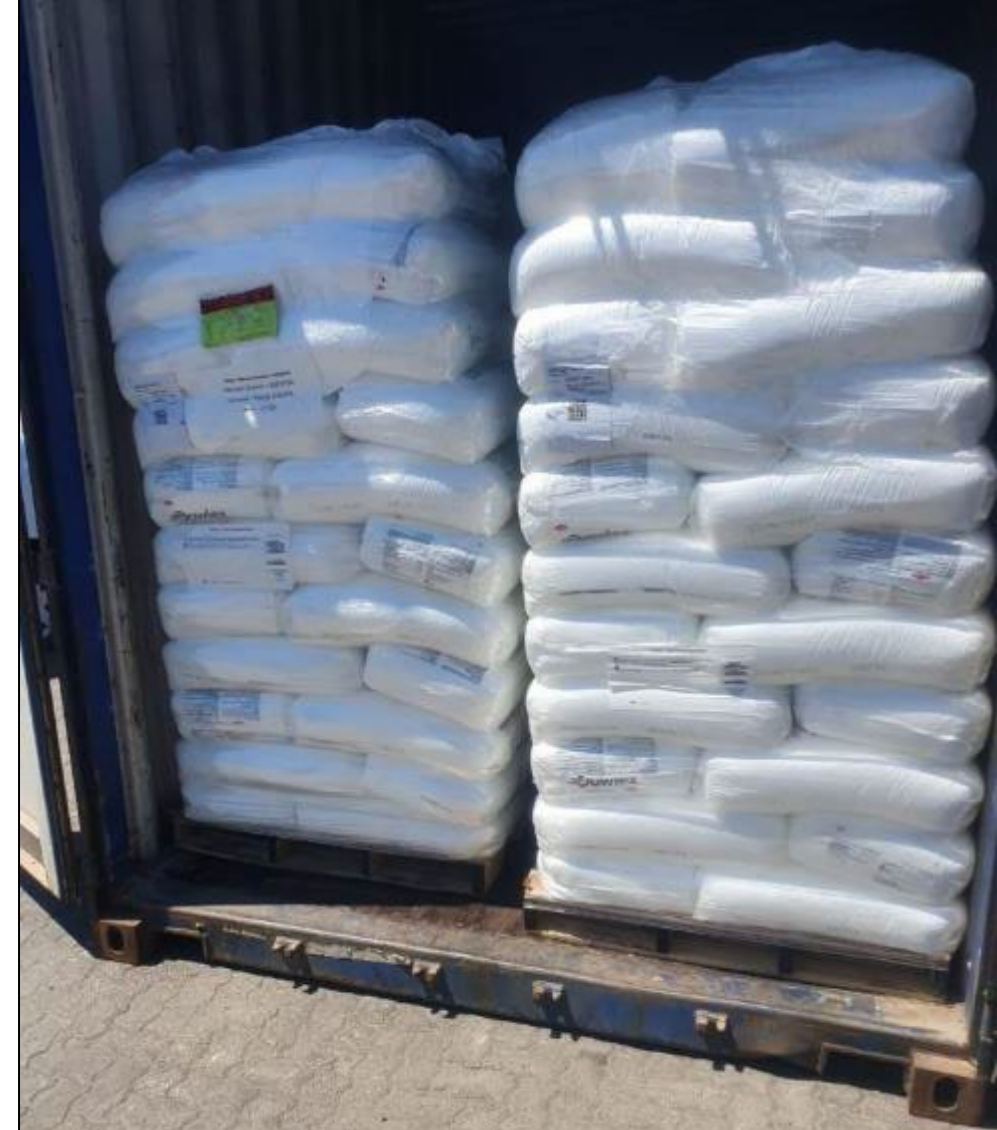
Transportation

1 x Nurdle =
~0.025g

1 x Bag = 25kg

1 Bag = ~1,000,000
Nurdles

1 x Container =
~980 Bags

1 x Container =
~25MT

1 x Container =
~1,000,000,000
Nurdles

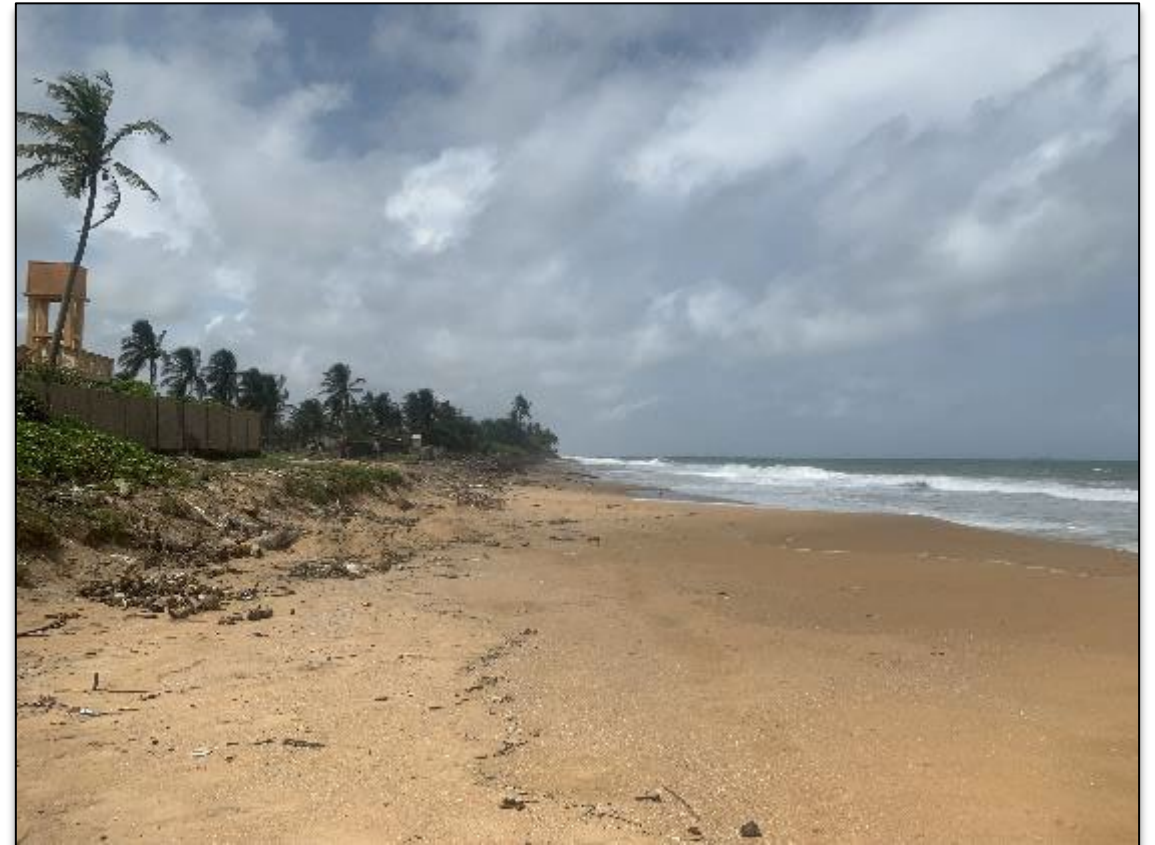
BEFORE

- Shoreline at Sarakkuwa

AFTER
