# 20 years after the NAKHODKA accident ~ Looking Backward and Looking Forward ~

# Japan Coast Guard

February 2, 2017

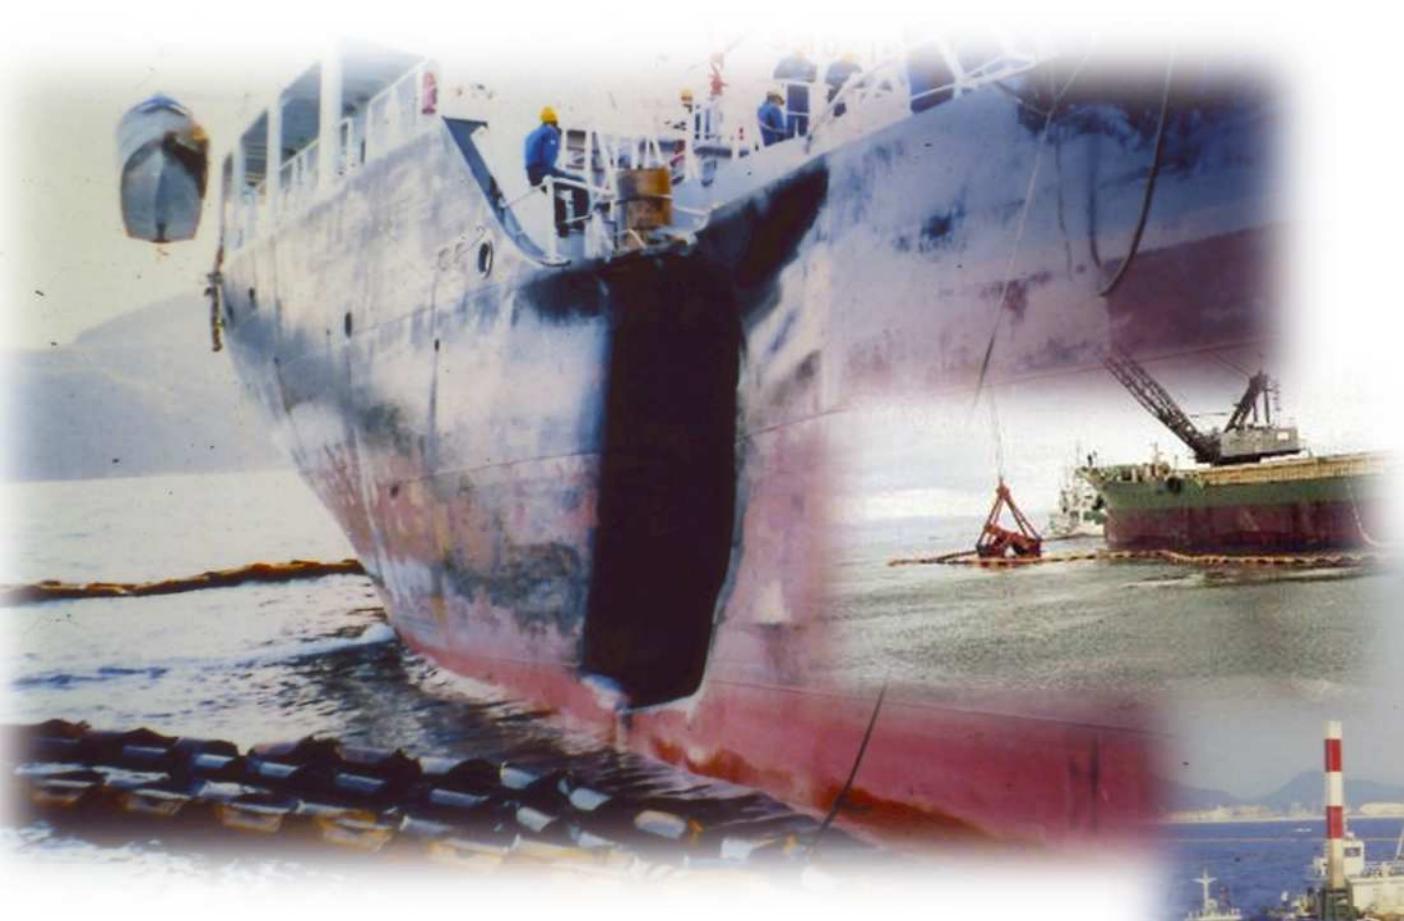
October 1994, Collision of the "TOYOTAKA MARU" A domestic tanker collided with a moored tanker named "TOYOTAKA MARU". Location: Wakaura Bay in Wakayama Pref. Spilled oil: Crued oil, 570k?

Oil viscosity was high and oil was quickly enclosed by oil booms. So almost all the oil has been recovered by the bucket of the crane ship.

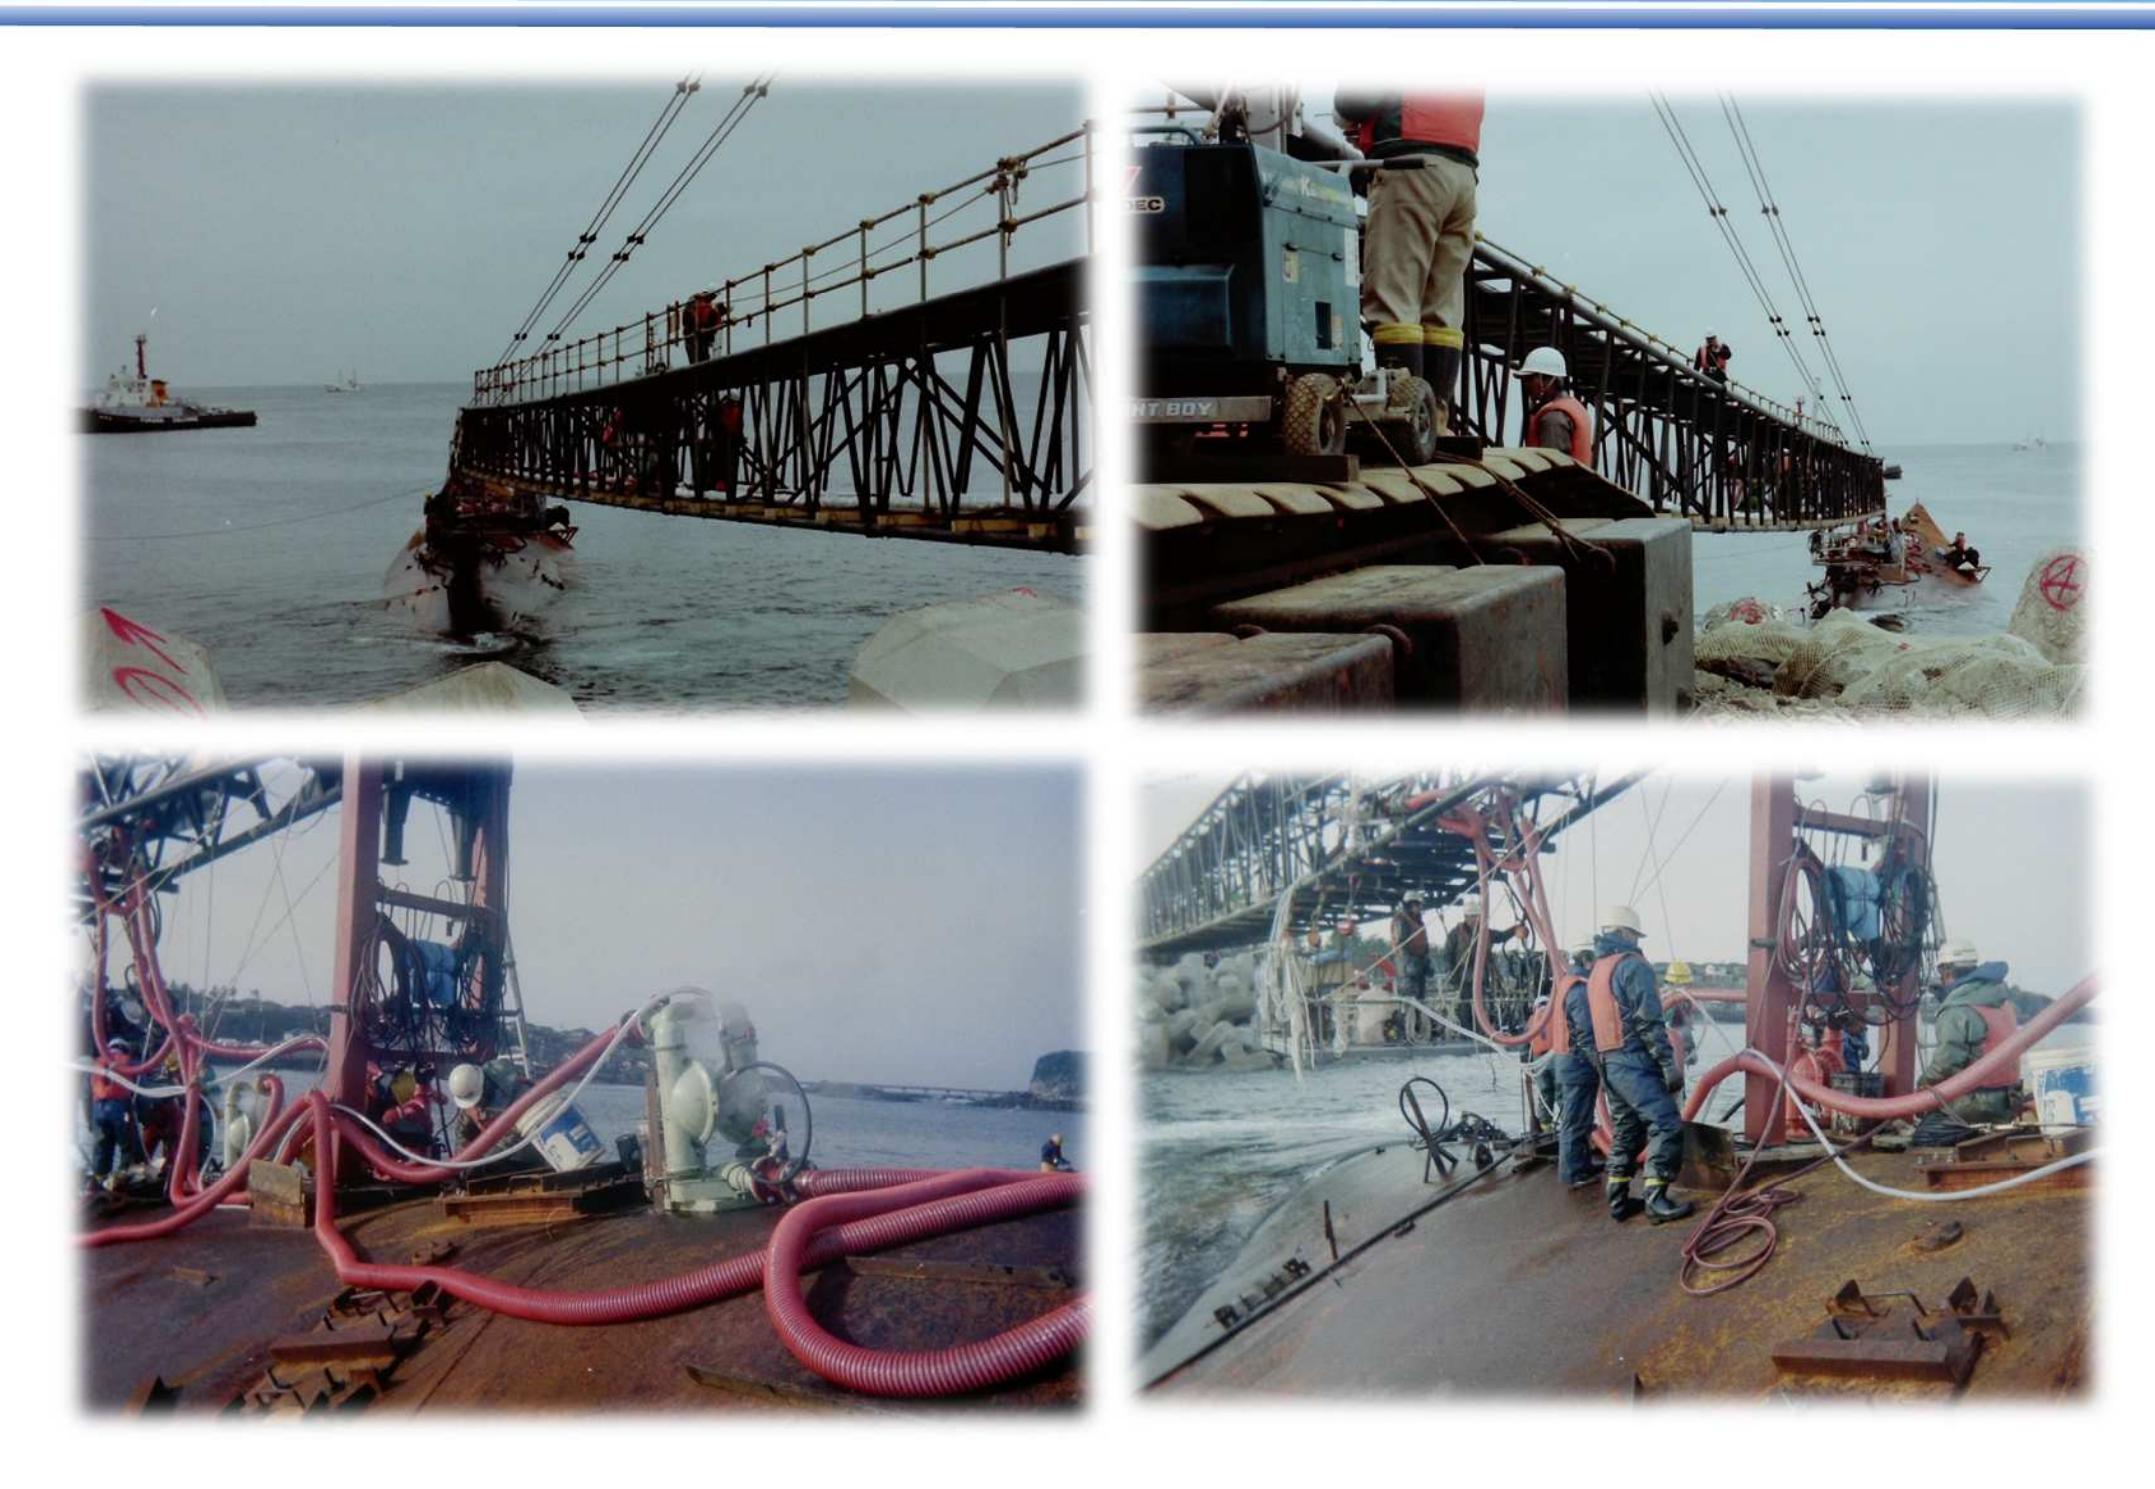
Construction of a temporary road from the coast to the bow part of NAKHODKA

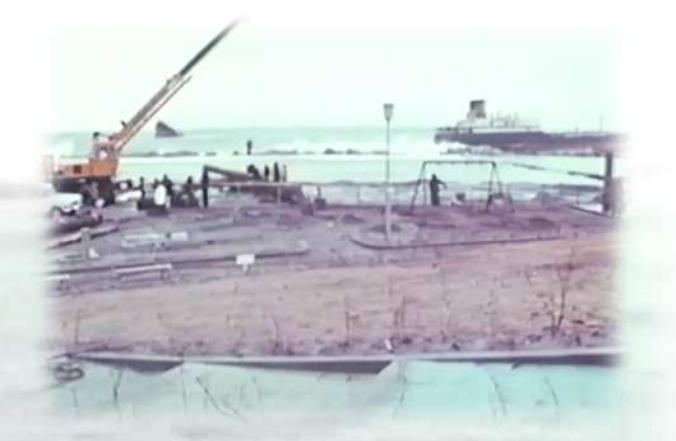
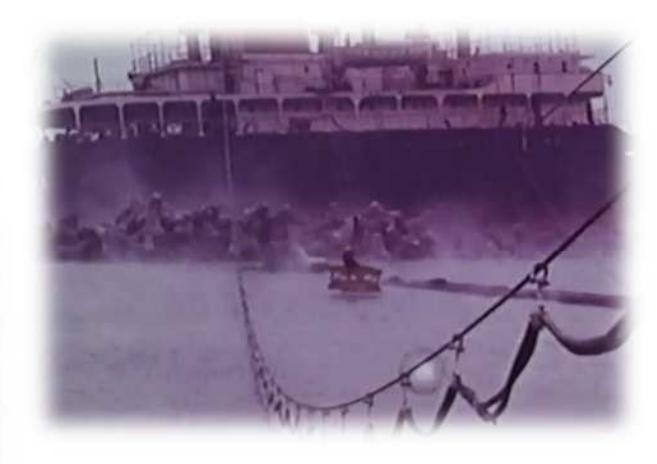
Plant piping from the coast to "JULIANA" on the seabed. <u>Remove oil remaining in Juliana from the land side.</u>

> Crude oil extraction operation Extraction ship Power supply ship Extraction ship

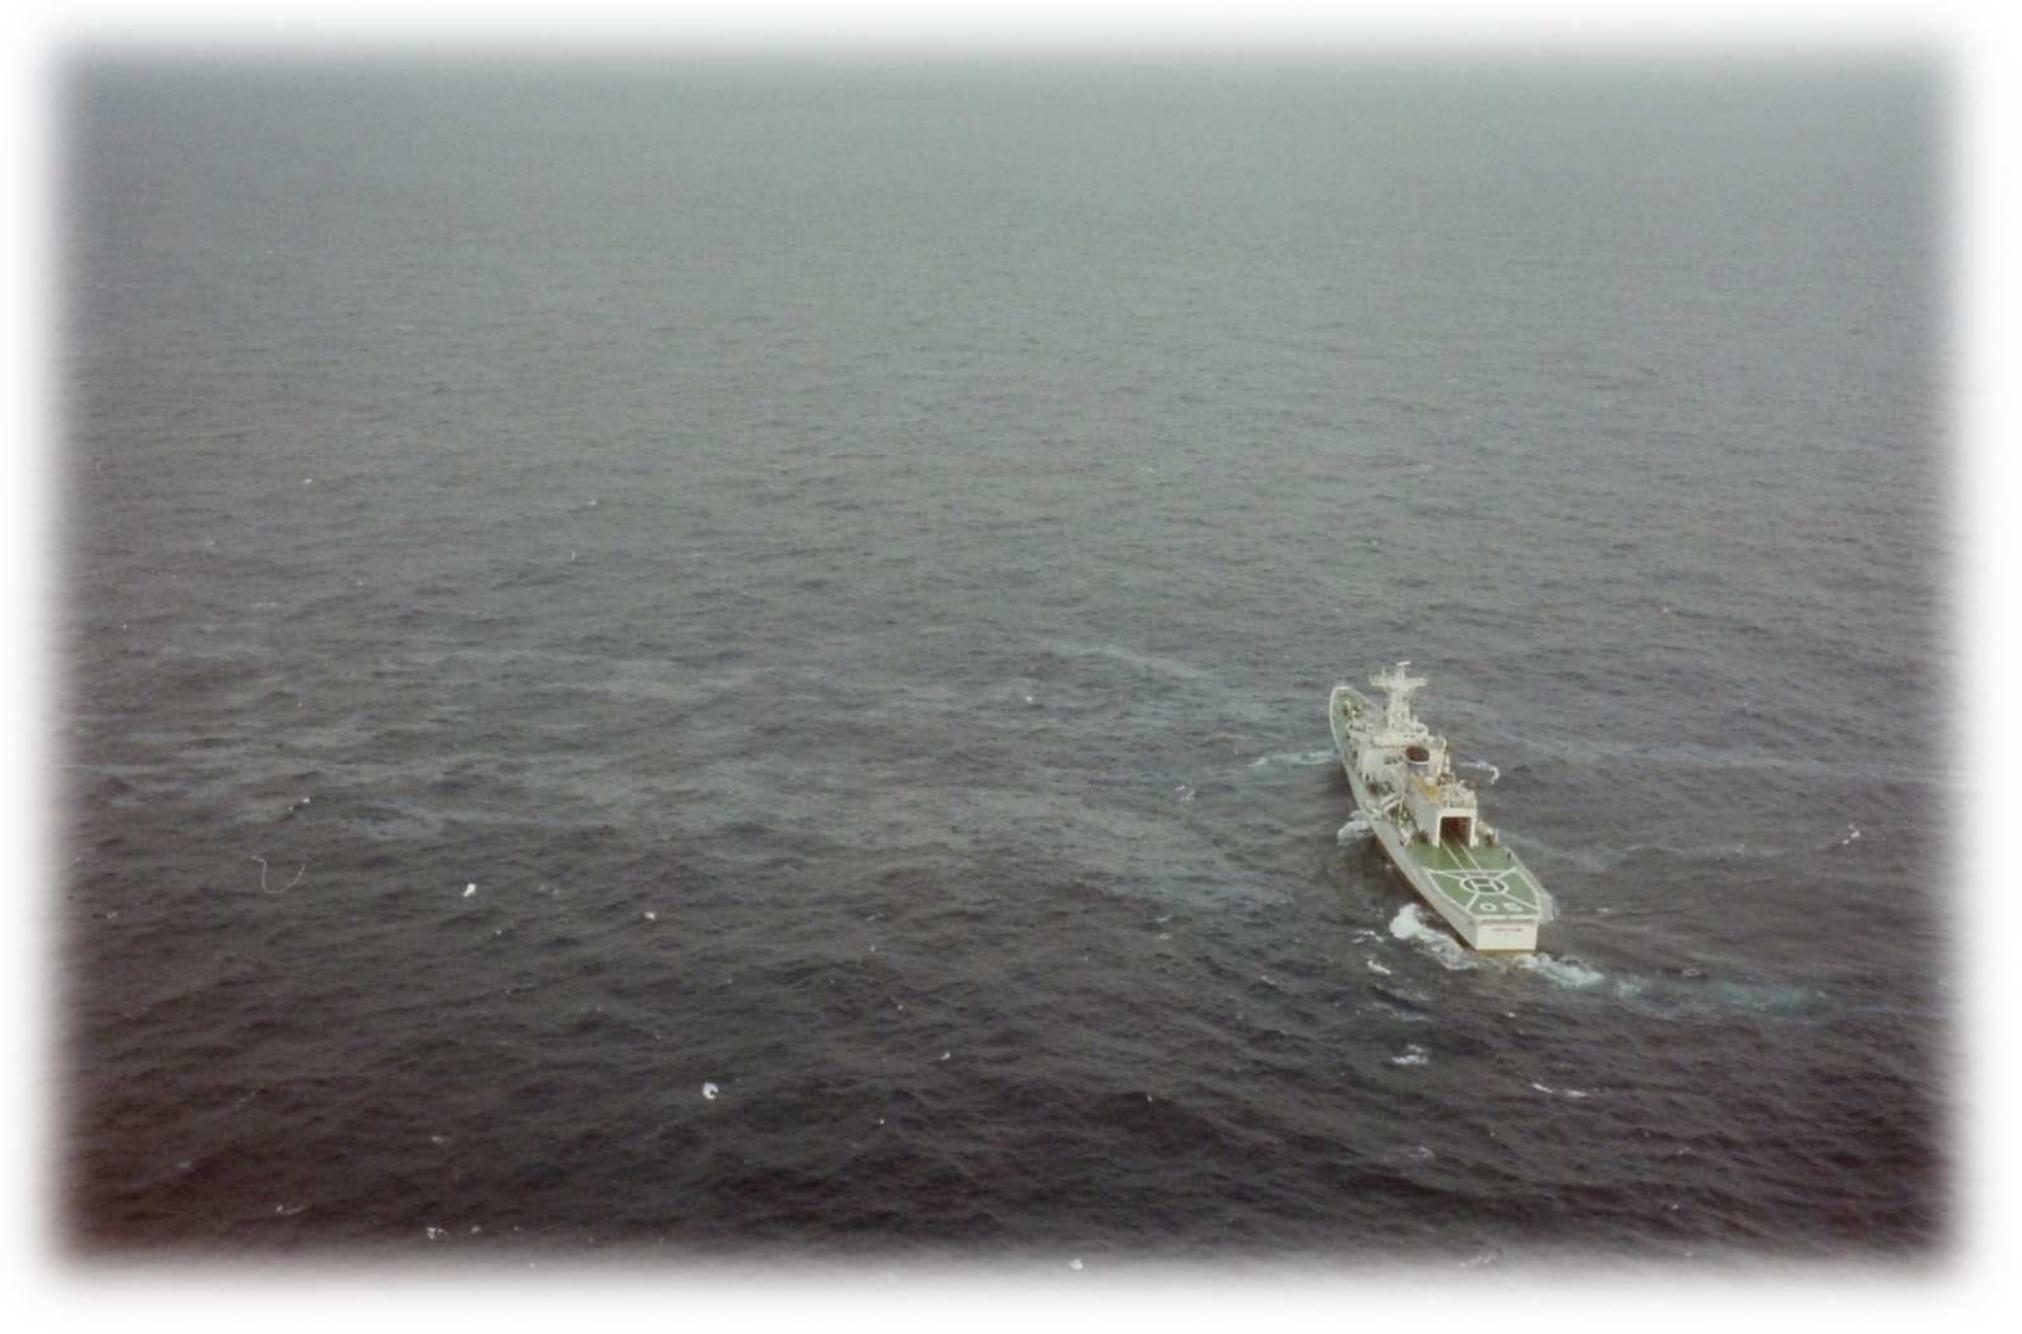
# The coming up oil from the stern part of "NAKHODKA"

The stern part of "NAKHODKA" was surveyed by an unmanned deep-sea vehicle called "Dolphin-3K" with the assistance received from Japan Agency for Maritime-Earth Science and Technology Center (JAMSTEC).

Carrying about 10,000k& of heavy oil, The ship body sank to the bottom at a depth of 2,500m Photo offered by JAMSTEC
